## General Information

| Make | Toyota | Model | Hilux Tamaraw |
| Registration No. | NJK7133 | Chassis No. | PAHACACA4S6429315 |

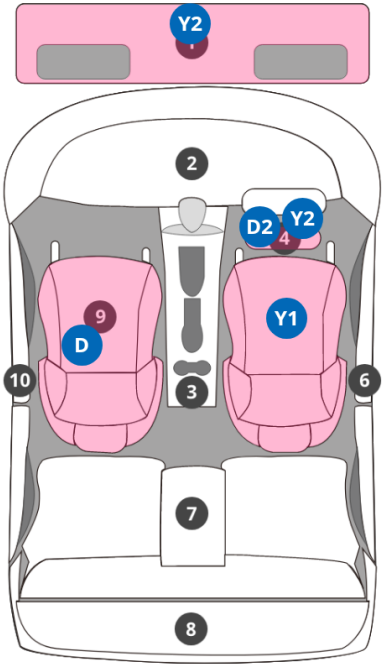
| Interior Evaluation : <b>B</b> | Exterior Evaluation : <b>E</b> |
|---|---|
| <b>Remarks</b><br>(R) Front Floor Mat - Grime - Small / (R) Front Seat - Grime - Minimal / (L) Front Floor Mat - Worked - Small / Ceiling - Grime - Small / (L) Front Seat - Worn - Yes | <b>Remarks</b><br>(L) Front Fender, Molding - Scratch - Minimal / (L) Mirror - Scratch - Minimal / (L) Front Door, Molding - Scratch - Medium / (L) Step, In-panel, Side Spoiler - Scratch - Small / Roof - Dent - Medium / (L) Side Gate - Scratch - Large / Rear Bumper, Lamps, Panels - Scratch - Medium / Rear Gate - Scratch - Small / Cargo Bed Floor - Scratch - Large / (R) Side Gate - Scratch - Large / (R) Front Door, Molding - Scratch - Small / (R) Step, In-panel, Side Spoiler - Scratch - Small / (R) Front Fender, Molding - Scratch - Minimal / Front Bumper, Grille, Lamps - Crack, Gap - Medium / Bonnet, Headlight - Scratch - Minimal |

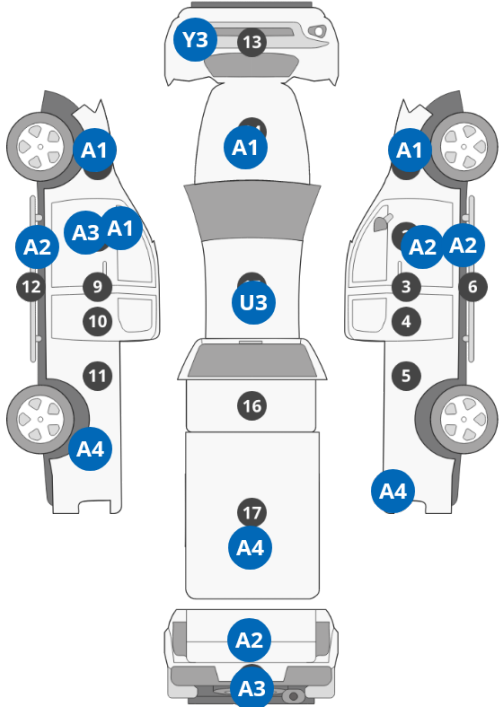
| Inspector Notes |
|---|
| with LTO plate/with warranty booklet/with tools and jack/with spare tire/scratches on taillight cover/hairline scratches on the body/with spare key/scratches on side windows |
