## General Information

| Make | Toyota | Model | Hilux Tamaraw |

## Body / Panel Condition

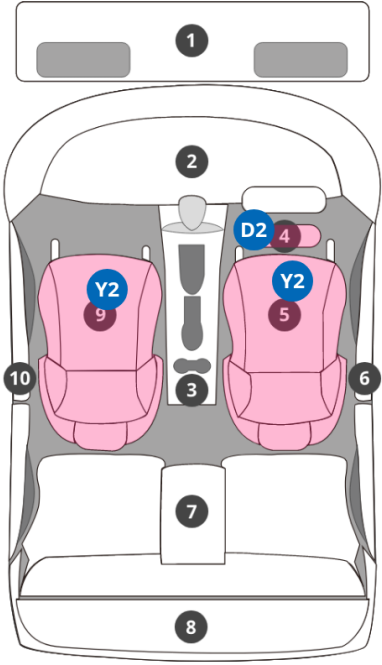
| Interior Evaluation : <b>A</b> | Exterior Evaluation : <b>C</b> |
|---|---|
| <b>Remarks</b><br>(R) Front Seat - Grime - Small / (L) Front Floor Mat - Worked - Small / (L) Front Seat - Grime - Small | <b>Remarks</b><br>(R) Front Fender, Molding - Scratch - Minimal / (R) Mirror - Scratch - Minimal / (R) Front Door, Molding - Scratch - Small / (R) Side Gate - Scratch - Medium / Rear Bumper, Lamps, Panels - Scratch - Small / Rear Gate - Scratch - Small / Cargo Bed Floor - Scratch & Dent - Small / (L) Side Gate - Scratch - Small / (L) Front Door, Molding - Scratch - Small / (L) Mirror - Scratch - Minimal / (L) Front Fender, Molding - Scratch - Minimal / Front Bumper, Grille, Lamps - Modified - Small / Front Bumper, Grille, Lamps - Scratch - Small / Bonnet, Headlight - Scratch - Minimal / Roof - Scratch - Minimal |

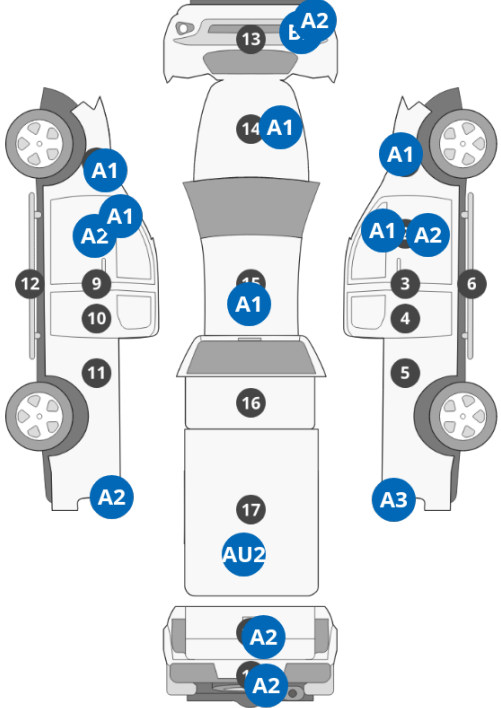
with warranty booklet, jack and tools, with spare tire, with LTO plate, scratches on tail light
