## General Information

| Make | Toyota | Model | Veloz |
| YOM | 2025 | Odo Meter Reading | 15,563 |
| Registration No. | NJA9506 | Chassis No. | MHFAB1BY2S3136482 |

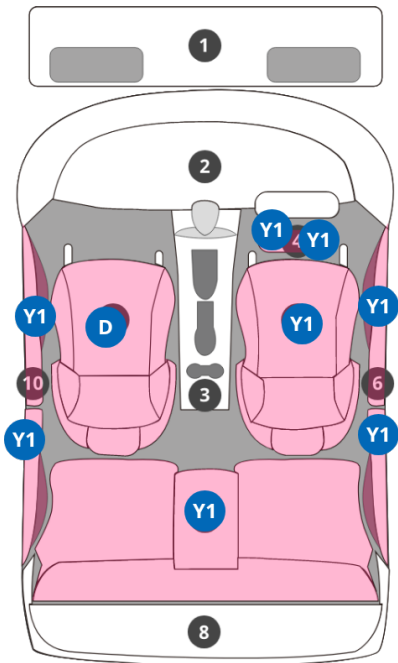
| Interior Evaluation : <b>B</b> | Exterior Evaluation : <b>C</b> |
|---|---|
| <b>Remarks</b><br>(R) Front Seat - Grime - Minimal / (L) Front Seat - Worn - Yes / Rear Seat - Grime - Minimal / (R) Rear Trim - Grime - Minimal / (L) Rear Trim - Grime - Minimal / (R) Front Trim - Grime - Minimal / (L) Front Trim - Grime - Minimal / (R) Front Floor Mat - Grime - Minimal / (L) Front Floor Mat - Grime - Minimal | <b>Remarks</b><br>(R) Front Fender, Molding - Scratch - Minimal / (R) Step, In-panel, Side Spoiler - Scratch - Small / (R) Front Door, Molding - Scratch - Minimal / (R) Rear Door, Molding - Scratch - Small / (R) Rear Fender, Molding - Scratch - Minimal / Rear Bumper, Lamps, Panels - Scratch - Small / Trunk Hood, Rear Gate - Scratch - Minimal / (L) Rear Fender, Molding - Scratch - Small / (L) Step, In-panel, Side Spoiler - Scratch - Small / (L) Rear Door, Molding - Scratch - Minimal / (L) Front Door, Molding - Scratch - Minimal / (L) Front Fender, Molding - Crack, Gap - Small / Front Bumper, Grille, Lamps - Scratch - Small / Bonnet, Headlight - Scratch - Small / Roof - Scratch - Minimal |

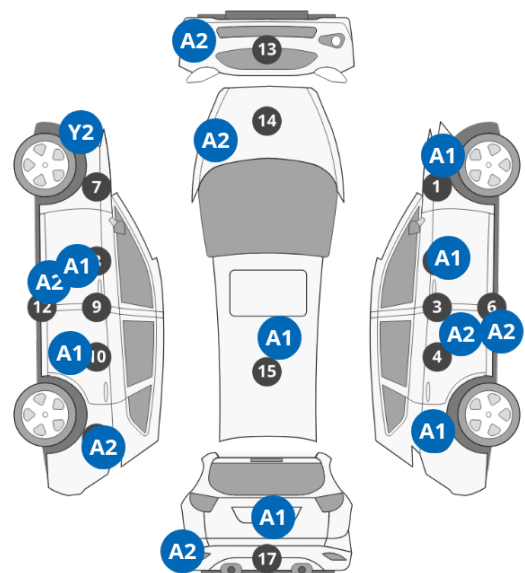
| Inspector Notes |
|---|
| with LTO plate/with warranty booklet/with incomplete tools with jack/with spare tire/with spare key/with seat cover/hairline scratches on the body/fog lights issue |
