## General Information

| Make | Toyota | Model | Wigo |

## Body / Panel Condition

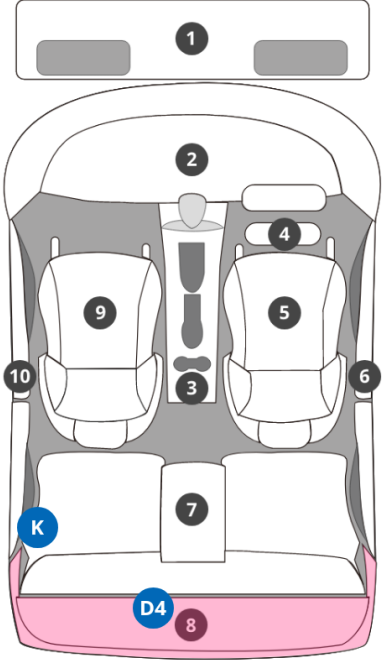
| <b>Interior Evaluation :</b> <span style="color: red; font-weight: bold;">C</span> | <b>Exterior Evaluation :</b> <span style="color: red; font-weight: bold;">D</span> |
| <b>Remarks</b><br>Overall Interior - Animal Hair - Yes / Trunk Room - Loose, Deformed - Large | <b>Remarks</b><br>(R) Step - Repair Traces - Yes / (R) Front Fender - Repair Traces - Yes / (R) Rear Door - Repair Traces - Yes / Front Bumper, Grille, Lamps - Scratch & Dent - Medium / Front Bumper, Grille, Lamps - Repair mark - Yes / Roof - Dent - Small / (R) Rear Door, Molding - Scratch - Small / (R) Rear Fender, Molding - Scratch - Minimal / Rear Bumper, Lamps, Panels - Scratch - Small / Bonnet, Headlight - Scratch - Medium / (L) Front Fender, Molding - Scratch - Small / (L) Rear Door, Molding - Dent - Medium / (L) Front Door, Molding - Scratch - Small / (L) Step, In-panel, Side Spoiler - Scratch & Dent - Minimal / (R) Step, In-panel, Side Spoiler - Scratch & Dent - Large / (R) Front Door, Molding - Scratch - Minimal |
