## General Information

| Make | Toyota | Model | Vios |
| YOM | 2018 | Odo Meter Reading | 171,240 |
| Registration No. | NAP3423 | Chassis No. | PA1B19F35J4061080 |

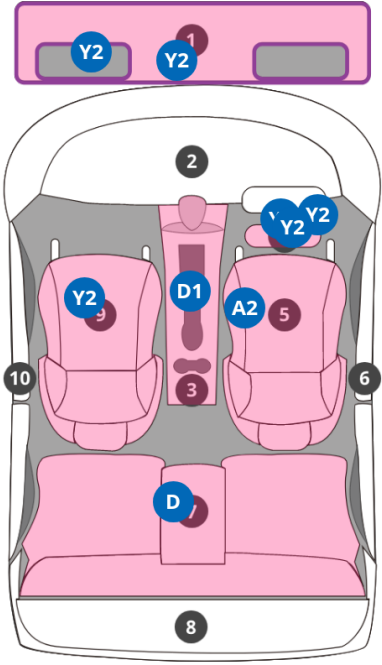
| Interior Evaluation : <span style="color: red;">C</span> | Exterior Evaluation : <span style="color: red;">E</span> |
| <b>Remarks</b><br>(R) Front Seat - Fray - Small / Rear Seat - Worn - Yes / (L) Front Seat - Grime - Small / (L) Front Floor Mat - Grime - Small / (R) Front Floor Mat - Grime - Small / Mat Other - Grime - Small / Ceiling - Grime - Small / Sunvisor, Sunglass Holder - Grime - Small / Console, Switchs, Vents - Worked - Minimal / Room Lamp - Missing - Yes | <b>Remarks</b><br>(R) Front Door - Repair Traces - Yes / (R) Front Fender - Repair Traces - Yes / Bonnet - Repair Traces - Yes / (L) Front Fender - Repair Traces - Yes / (L) Front Door - Repair Traces - Yes / (L) Rear Door - Repair Traces - Yes / (L) Rear Fender - Repair Traces - Yes / Trunk Hood, Rear Gate - Repair Traces - Yes / (R) Rear Fender - Repair Traces - Yes / (R) Rear Door - Repair Traces - Yes / Trunk Hood, Rear Gate - Scratch & Dent - Small / Rear Bumper, Lamps, Panels - Scratch - Medium / (R) Rear Fender, Molding - Crack, Gap - Medium / (R) Rear Door, Molding - Scratch & Dent - Medium / (R) Step, In-panel, Side Spoiler - Scratch & Dent - Large / (R) Front Door, Molding - Repair mark - Yes / (R) Rear Door, Molding - Repair mark - Yes / (R) Front Door, Molding - Scratch - Large / (R) Front Fender, Molding - Scratch - Medium / Front Bumper, Grille, Lamps - Scratch - Medium / (L) Front Fender, Molding - Scratch & Dent - Medium / (L) Front Door, Molding - Scratch & Dent - Medium / (L) Step, In-panel, Side Spoiler - Scratch & Dent - Medium / (L) Rear Door, Molding - Scratch & Dent - Small / (L) Rear Fender, Molding - Scratch & Dent - Small / Roof - Scratch & Dent - Small / Overall Exterior - Faded(Color, Gloss) - Yes / Front Bumper, Grille, Lamps - Repair mark - Yes / Bonnet, Headlight - Scratch & Dent - Small |

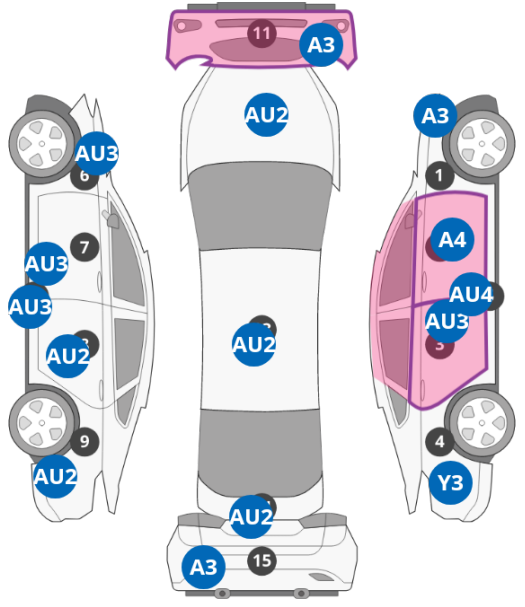
with LTO plate, with spare tire, no tools and jack, no warranty and manual booklet, no spare key, issue in foglamps, issue in headlight, scratches and yellowing in headlight and taillight, scratches and dent on exterior, scratches on taillight and headlight, idle vibration, horn issue.
