## General Information

| Make | Toyota | Model | Vios |
| YOM | 2018 | Odo Meter Reading | 190,883 |
| Registration No. | NAJ9472 | Chassis No. | PA1B19F3XH4052756 |

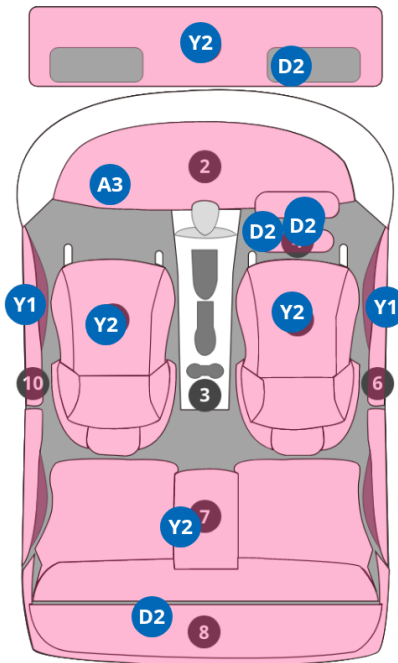
| Interior Evaluation : <span style="color: red;">C</span> | Exterior Evaluation : <span style="color: red;">E</span> |
|---|---|
| <p><b>Remarks</b></p> <p>(L) Front Floor Mat - Worked - Small / (R) Front Floor Mat - Worked - Small / (L) Front Seat - Grime - Small / (R) Front Seat - Grime - Small / Rear Seat - Grime - Small / Mat Other - Worked - Small / (L) Front Trim - Grime - Minimal / (R) Front Trim - Grime - Minimal / Steering Wheel - Worn, Peel, Crack - Medium / Ceiling - Grime - Small / Sunvisor, Sunglass Holder - Worked - Small / Trunk Room - Loose, Deformed - Small / Overall Interior - Worn as per age - Yes</p> | <p><b>Remarks</b></p> <p>(R) Front Door - Repair Traces - Yes / (R) Front Fender - Repair Traces - Yes / Bonnet - Repair Traces - Yes / (L) Front Fender - Repair Traces - Yes / Trunk Hood, Rear Gate - Repair Traces - Yes / (R) Rear Fender - Repair Traces - Yes / (R) Rear Door - Repair Traces - Yes / Overall Exterior - Color Change - Yes / Overall Exterior - Faded(Color, Gloss) - Yes / Overall Exterior - Re-Paint Uneven - Yes / (L) Front Fender, Molding - Scratch &amp; Dent - Medium / (L) Step, In-panel, Side Spoiler - Repair mark - Yes / (L) Front Door, Molding - Scratch - Medium / (L) Rear Door, Molding - Scratch &amp; Dent - Small / (L) Step, In-panel, Side Spoiler - Scratch &amp; Dent - Medium / (L) Rear Fender, Molding - Scratch - Medium / Trunk Hood, Rear Gate - Modified - Medium / Trunk Hood, Rear Gate - Scratch &amp; Dent - Minimal / Rear Bumper, Lamps, Panels - Scratch - Medium / (R) Rear Fender, Molding - Crack, Gap - Medium / (R) Rear Fender, Molding - Repair mark - Yes / (R) Rear Door, Molding - Repair mark - Yes / (R) Rear Door, Molding - Scratch &amp; Dent - Large / (R) Step, In-panel, Side Spoiler - Scratch &amp; Dent - Small / (R) Step, In-panel, Side Spoiler - Repair mark - Yes / (R) Front Door, Molding - Scratch - Medium / (R) Front Fender, Molding - Repair mark - Yes / (R) Front Fender, Molding - Scratch - Medium / Front Bumper, Grille, Lamps - Scratch - Medium / Bonnet, Headlight - Scratch &amp; Dent - Small / Roof - Scratch &amp; Dent - Small</p> |
