## General Information

| Make | Toyota | Model | Veloz |
| YOM | 2025 | Odo Meter Reading | 20,696 |
| Registration No. | NJA6241 | Chassis No. | MHFAB1BY6S3133536 |

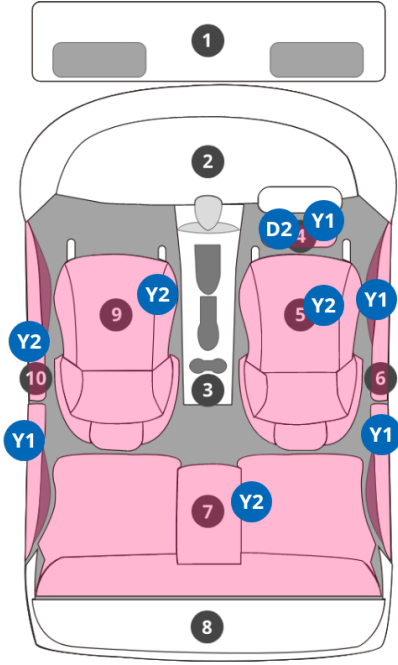
| Interior Evaluation : <b>B</b> | Exterior Evaluation : <b>E</b> |
| <p><b>Remarks</b></p> <p>(R) Front Seat - Grime - Small / Rear Seat - Grime - Small / (R) Front Trim - Grime - Minimal / (R) Rear Trim - Grime - Minimal / (L) Rear Trim - Grime - Minimal / (L) Front Trim - Grime - Small / (L) Front Seat - Grime - Small / (L) Front Floor Mat - Worked - Small / (R) Front Floor Mat - Grime - Minimal</p> | <p><b>Remarks</b></p> <p>(R) Front Fender - Repair Traces - Yes / (R) Front Fender, Molding - Repair mark - Yes / (R) Rear Fender, Molding - Repair mark - Yes / (L) Rear Fender, Molding - Scratch - Large / (L) Rear Door, Molding - Scratch - Medium / (L) Step, In-panel, Side Spoiler - Scratch - Medium / (L) Front Door, Molding - Scratch - Large / (L) Front Fender, Molding - Scratch &amp; Dent - Large / Front Bumper, Grille, Lamps - Scratch &amp; Dent - Large / Bonnet, Headlight - Scratch - Minimal / (R) Front Fender, Molding - Crack, Gap - Small / (R) Mirror - Scratch - Minimal / Rear Bumper, Lamps, Panels - Scratch - Small / Trunk Hood, Rear Gate - Scratch - Minimal / (R) Rear Fender, Molding - Scratch - Small / (R) Step, In-panel, Side Spoiler - Scratch - Small / (R) Rear Door, Molding - Scratch - Minimal / (R) Front Door, Molding - Scratch - Minimal / Roof - Scratch &amp; Dent - Minimal</p> |

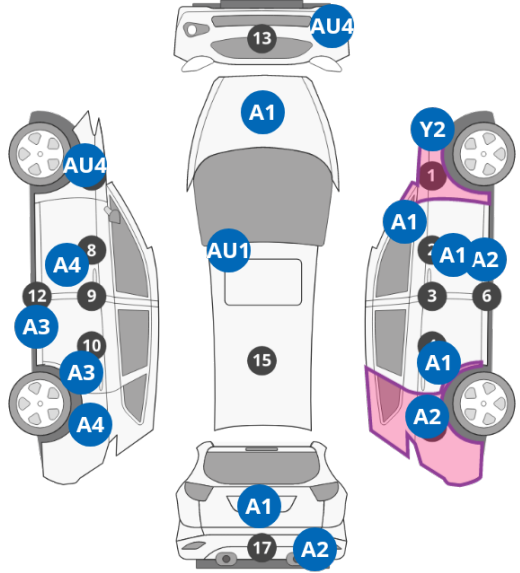
| Inspector Notes |
|---|
| <p>with LTO plate/no warranty booklet/incomplete tools no jack/with spare tire/front bumper partially missing/with spare key/hairline scratches on the body/passenger door handle issue</p> |
