## General Information

| Make | Toyota | Model | Vios |

## Body / Panel Condition

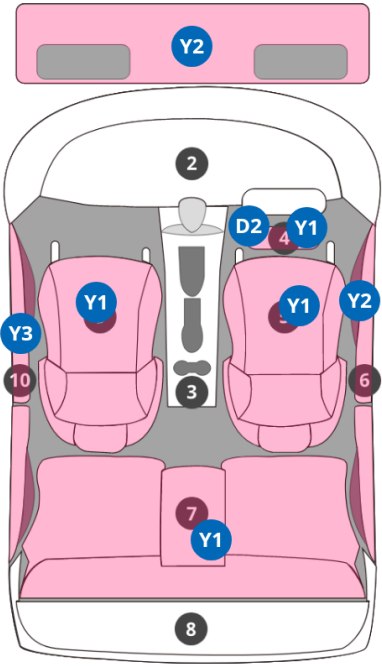
| <b>Interior Evaluation :</b> <span style="color: red; font-weight: bold;">C</span> | <b>Exterior Evaluation :</b> <span style="color: red; font-weight: bold;">E</span> |
| <b>Remarks</b><br>(R) Front Seat - Grime - Minimal / Rear Seat - Grime - Minimal / (L) Front Seat - Grime - Minimal / (R) Front Trim - Grime - Small / (R) Front Floor Mat - Grime - Minimal / (L) Front Floor Mat - Worked - Small / (L) Front Trim - Grime - Medium / Ceiling - Grime - Small / Overall Interior - Worn as per age - Yes | <b>Remarks</b><br>(R) Front Door - Repair Traces - Yes / (R) Step - Repair Traces - Yes / (R) Front Fender - Repair Traces - Yes / Bonnet - Repair Traces - Yes / (L) Front Fender - Repair Traces - Yes / (L) Front Door - Repair Traces - Yes / (L) Step - Repair Traces - Yes / (L) Rear Door - Repair Traces - Yes / (L) Rear Fender - Repair Traces - Yes / Trunk Hood, Rear Gate - Repair Traces - Yes / (R) Rear Fender - Repair Traces - Yes / (R) Rear Door - Repair Traces - Yes / Roof - Repair Traces - Yes / Trunk Hood, Rear Gate - Repair mark - Yes / (R) Front Fender, Molding - Repair mark - Yes / (R) Front Door, Molding - Repair mark - Yes / (R) Rear Door, Molding - Repair mark - Yes / (R) Rear Fender, Molding - Repair mark - Yes / (L) Front Fender, Molding - Repair mark - Yes / Bonnet, Headlight - Repair mark - Yes / Rear Bumper, Lamps, Panels - Repair mark - Yes / Rear Bumper, Lamps, Panels - Scratch - Large / Trunk Hood, Rear Gate - Scratch - Medium / (L) Rear Fender, Molding - Scratch - Medium / (L) Step, In-panel, Side Spoiler - Scratch - Small / (L) Rear Door, Molding - Scratch - Large / (L) Front Door, Molding - Scratch - Large / (L) Front Fender, Molding - Scratch - Small / Front Bumper, Grille, Lamps - Scratch - Medium / Bonnet, Headlight - Scratch - Small / (R) Front Fender, Molding - Crack, Gap - Small / (R) Step, In-panel, Side Spoiler - Scratch - Small / (R) Front Door, Molding - Scratch - Small / (R) Rear Door, Molding - Scratch - Small / (R) Rear Fender, Molding - Scratch - Small / Roof - Scratch & Dent - Minimal / (R) Mirror - Scratch - Minimal / (L) Mirror - Scratch - Minimal / Overall Exterior - Re-Paint Uneven - Yes |

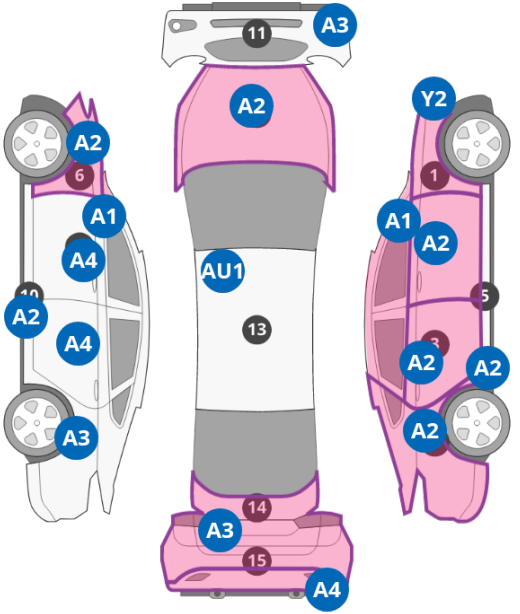
with LTO plate/no warranty booklet/with incomplete tools with jack/with spare tire/no remote key/wiper issue/reverse light issue/scratches on tailight and headlight cover/with seat cover/hairline scratches on the body
