## General Information

| Make | Toyota | Model | Vios |
| YOM | 2024 | Odo Meter Reading | 119,784 |

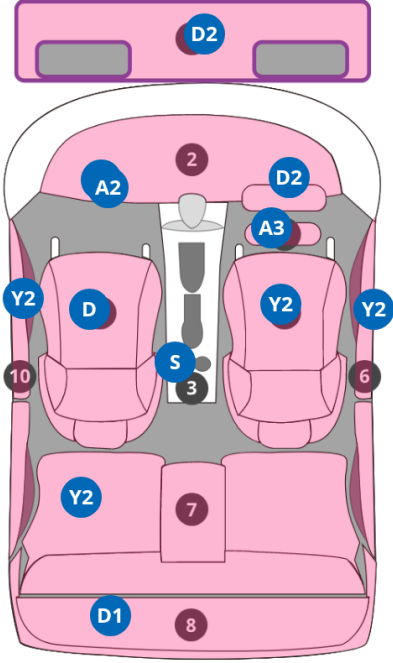
| Interior Evaluation : <b>C</b> | Exterior Evaluation : <b>E</b> |
| <p><b>Remarks</b></p> <p>(L) Front Floor Mat - Cut, Crack - Medium / Rear Seat - Grime - Small / (L) Front Trim - Grime - Small / (R) Front Trim - Grime - Small / Dashboard - Traces of Adhesive Tape - Yes / Glove Box - Loose, Deformed - Small / (L) Front Seat - Worn - Yes / (R) Front Seat - Grime - Small / Trunk Room - Worked - Minimal / Ceiling - Crinkle - Small / Overall Interior - Smell - Yes / Steering Wheel - Worn, Peel, Crack - Small / Room Lamp - Missing - Yes</p> | <p><b>Remarks</b></p> <p>(R) Front Fender - Repair Traces - Yes / Bonnet - Repair Traces - Yes / (L) Front Fender - Repair Traces - Yes / Trunk Hood, Rear Gate - Repair Traces - Yes / Rear Bumper, Lamps, Panels - Crack, Gap - Medium / Trunk Hood, Rear Gate - Scratch &amp; Dent - Small / (L) Rear Fender, Molding - Scratch &amp; Dent - Small / (L) Rear Door, Molding - Scratch &amp; Dent - Small / (L) Front Door, Molding - Scratch &amp; Dent - Small / (L) Step, In-panel, Side Spoiler - Scratch &amp; Dent - Small / Roof - Scratch &amp; Dent - Small / (L) Front Fender, Molding - Scratch - Small / Bonnet, Headlight - Scratch - Large / (R) Front Fender, Molding - Scratch &amp; Dent - Small / (R) Front Door, Molding - Scratch &amp; Dent - Minimal / (R) Step, In-panel, Side Spoiler - Scratch &amp; Dent - Medium / (R) Rear Door, Molding - Scratch &amp; Dent - Small / (R) Rear Fender, Molding - Modified - Small / Front Bumper, Grille, Lamps - Scratch - Medium</p> |

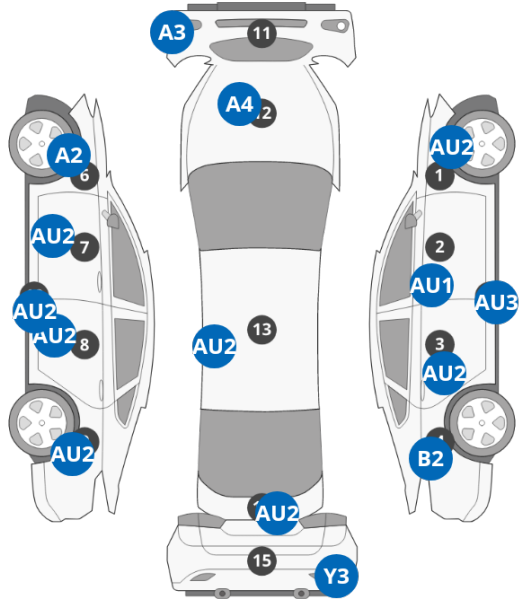
| Inspector Notes |
|---|
| <p>with LTO plate, with spare tire and key, with jack, no warranty and manual booklet, no reverse camera, no tools, scratches and dent on exterior, scratches in taillight and headlight, issue in headlight bulb.</p> |
