## General Information

| Make | Toyota | Model | Vios |
| YOM | 2025 | Odo Meter Reading | 19,526 |

## Body / Panel Condition

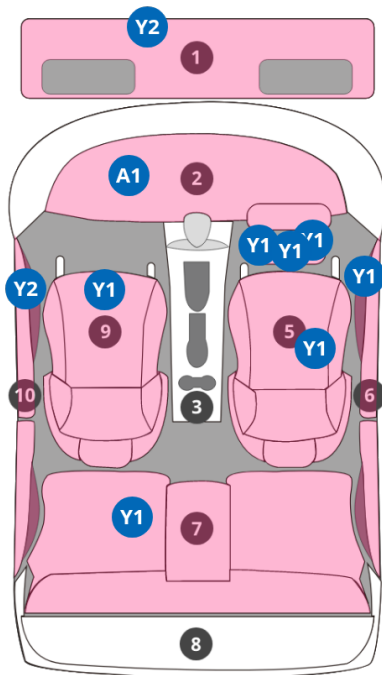
| Interior Evaluation : <b>B</b> | Exterior Evaluation : <b>D</b> |
| <p><b>a</b> : Cut, Fray <b>d</b> : Loose, Deformed <b>k</b> : Animal Hair <b>s</b> : Smell <b>t</b> : Cigarette Burns <b>x</b> : Defective <b>y</b> : Stain</p> | <p><b>A</b> : Scratch <b>AU</b> : Scratch &amp; Dent <b>B</b> : Modified <b>C</b> : Corrosion <b>G</b> : Stone chip <b>P</b> : Faded <b>S</b> : Rust <b>SC</b> : Rust &amp; Corrosion <b>U</b> : Dent <b>X</b> : Defective <b>Y</b> : Crack, Gap</p> |
| <p><b>Remarks</b></p> <p>Ceiling - Grime - Small / (R) Front Floor Mat - Grime - Minimal / (L) Front Floor Mat - Grime - Minimal / Mat Other - Grime - Minimal / (L) Front Seat - Grime - Minimal / (R) Front Seat - Grime - Minimal / Dashboard - Worn, Scratch, Cut, Crack - Minimal / Rear Seat - Grime - Minimal / (L) Front Trim - Grime - Small / (R) Front Trim - Grime - Minimal</p> | <p><b>Remarks</b></p> <p>(R) Front Fender, Molding - Scratch - Minimal / (R) Front Door, Molding - Scratch - Small / (R) Step, In-panel, Side Spoiler - Scratch &amp; Dent - Medium / (R) Rear Door, Molding - Scratch - Small / (R) Rear Fender, Molding - Scratch &amp; Dent - Medium / Rear Bumper, Lamps, Panels - Scratch - Large / (L) Rear Fender, Molding - Scratch &amp; Dent - Small / (L) Rear Door, Molding - Scratch &amp; Dent - Medium / (L) Front Door, Molding - Scratch - Minimal / (L) Step, In-panel, Side Spoiler - Scratch - Minimal / (L) Front Fender, Molding - Scratch - Minimal / Front Bumper, Grille, Lamps - Scratch - Medium / Bonnet, Headlight - Scratch - Minimal / Roof - Scratch - Minimal</p> |
