## General Information

| Make | Toyota | Model | Vios |
| Registration No. | NJK1600 | Chassis No. | PA1B18F37S4297998 |

## Body / Panel Condition

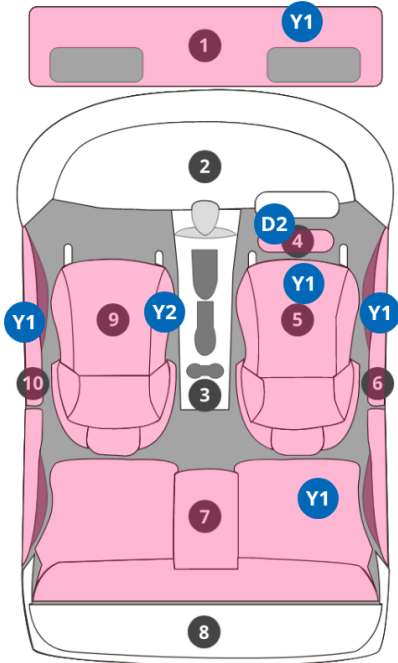
| Interior Evaluation : <span style="color: red; font-weight: bold;">A</span> | Exterior Evaluation : <span style="color: red; font-weight: bold;">D</span> |
|---|---|
| <p><b>Remarks</b><br/>(L) Front Floor Mat - Worked - Small / (R) Front Seat - Grime - Minimal / (L) Front Seat - Grime - Small / (L) Front Trim - Grime - Minimal / (R) Front Trim - Grime - Minimal / Ceiling - Grime - Minimal / Rear Seat - Grime - Minimal</p> | <p><b>Remarks</b><br/>(R) Front Fender, Molding - Scratch - Minimal / (R) Mirror - Scratch - Minimal / (R) Rear Fender, Molding - Scratch &amp; Dent - Large / (R) Rear Door, Molding - Scratch &amp; Dent - Large / (R) Front Door, Molding - Scratch - Small / Trunk Hood, Rear Gate - Scratch - Small / Rear Bumper, Lamps, Panels - Scratch &amp; Dent - Small / (L) Rear Fender, Molding - Scratch - Minimal / (L) Rear Door, Molding - Scratch &amp; Dent - Small / (L) Front Door, Molding - Scratch - Small / (L) Mirror - Scratch - Minimal / (L) Front Fender, Molding - Scratch - Minimal / Front Bumper, Grille, Lamps - Scratch - Medium / Bonnet, Headlight - Crack, Gap - Medium / Roof - Dent - Small</p> |

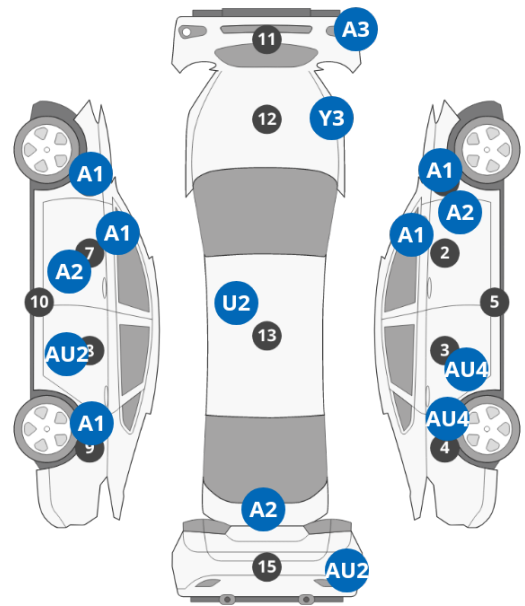
| Inspector Notes |
|---|
| with warranty booklet and jack, no tools, with spare tire, with LTO plate, scratches on tail light |
