## General Information

| Make | Toyota | Model | Wigo |

## Body / Panel Condition

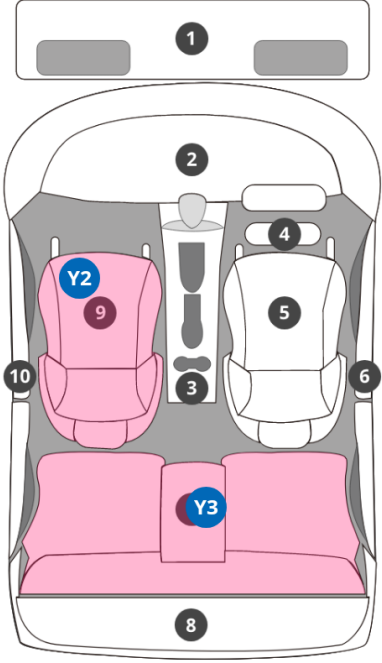
| Interior Evaluation : <b>B</b> | Exterior Evaluation : <b>D</b> |
|---|---|
| <p><b>Remarks</b><br/>Rear Seat - Grime - Medium / (L) Front Seat - Grime - Small</p> | <p><b>Remarks</b><br/>(L) Mirror - Scratch - Small / (L) Rear Door, Molding - Scratch - Large / (L) Rear Fender, Molding - Scratch - Small / (R) Mirror - Scratch - Small / (R) Front Door, Molding - Scratch &amp; Dent - Medium / (R) Rear Door, Molding - Scratch - Small / (R) Rear Fender, Molding - Scratch &amp; Dent - Medium / Front Bumper, Grille, Lamps - Scratch - Large / Rear Bumper, Lamps, Panels - Scratch - Small / (L) Front Door, Molding - Scratch &amp; Dent - Medium / (L) Front Fender, Molding - Scratch - Small</p> |
