## General Information

| Make | Toyota | Model | Vios |
| Registration No. | DBS1215 | Chassis No. | PA1B18F36R4280801 |

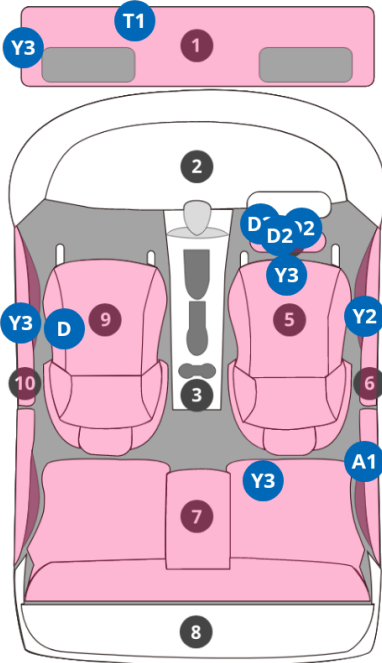
| Interior Evaluation : <b>C</b> | Exterior Evaluation : <b>D</b> |
| <p><b>Remarks</b><br/>(L) Front Seat - Worn - Yes / (R) Front Seat - Grime - Medium / (L) Front Trim - Grime - Medium / (R) Front Trim - Grime - Small / Ceiling - Grime - Medium / Rear Seat - Grime - Medium / (R) Rear Trim - Cut, Crack - Minimal / (L) Front Floor Mat - Worked - Small / (R) Front Floor Mat - Worked - Small / Ceiling - Cigarette Burns - Burnt Minimal</p> | <p><b>Remarks</b><br/>(R) Front Fender, Molding - Scratch - Small / (R) Mirror - Scratch - Minimal / (R) Step, In-panel, Side Spoiler - Scratch &amp; Dent - Medium / (R) Rear Door, Molding - Scratch - Medium / (R) Front Door, Molding - Scratch &amp; Dent - Medium / (R) Rear Fender, Molding - Scratch - Minimal / Rear Bumper, Lamps, Panels - Scratch - Small / Trunk Hood, Rear Gate - Scratch &amp; Dent - Small / (L) Rear Fender, Molding - Scratch - Minimal / (L) Front Door, Molding - Scratch - Small / (L) Rear Door, Molding - Scratch - Small / (L) Mirror - Scratch - Small / (L) Front Fender, Molding - Scratch - Minimal / Member (Bolted) - Dent - Yes / Front Bumper, Grille, Lamps - Scratch - Medium / Bonnet, Headlight - Scratch - Small / Roof - Scratch - Small</p> |

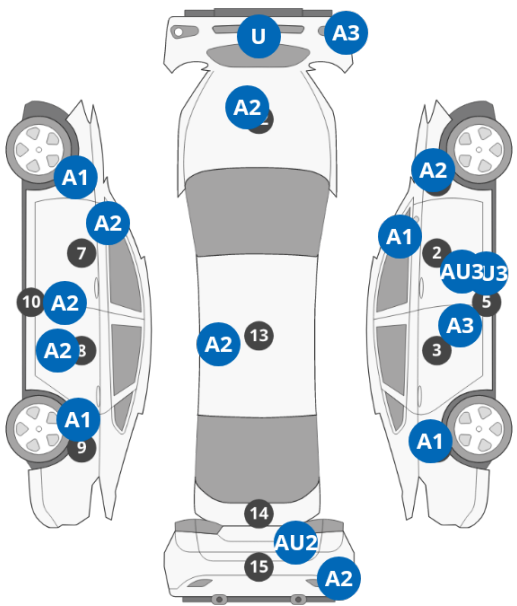
| Inspector Notes |
|---|
| with warranty booklet, no jack and tools, with spare tire, with LTO plate, scratches on tail light, possible flooding, |
