## General Information

| Make | Toyota | Model | Vios |

## Body / Panel Condition

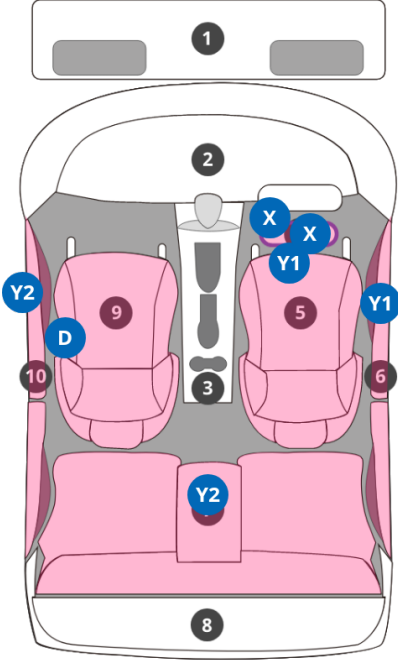
| Interior Evaluation : <b>B</b> | Exterior Evaluation : <b>C</b> |
|---|---|
| <b>Remarks</b><br>Rear Seat - Grime - Small / (R) Front Seat - Grime - Minimal / (R) Front Trim - Grime - Minimal / (R) Front Floor Mat - Missing - Yes / (L) Front Floor Mat - Missing - Yes / (L) Front Trim - Grime - Small / (L) Front Seat - Worn - Yes | <b>Remarks</b><br>(L) Front Door, Molding - Scratch - Small / (L) Rear Door, Molding - Scratch & Dent - Small / (L) Rear Fender, Molding - Scratch - Minimal / (L) Step, In-panel, Side Spoiler - Scratch - Small / (L) Front Fender, Molding - Scratch - Minimal / Bonnet, Headlight - Scratch & Dent - Medium / Front Bumper, Grille, Lamps - Scratch - Small / (R) Front Fender, Molding - Scratch - Minimal / (R) Front Door, Molding - Scratch & Dent - Small / (R) Rear Door, Molding - Scratch - Minimal / (R) Step, In-panel, Side Spoiler - Scratch & Dent - Large / (R) Rear Fender, Molding - Scratch - Small / Rear Bumper, Lamps, Panels - Scratch - Minimal / Trunk Hood, Rear Gate - Scratch - Minimal / Roof - Scratch - Minimal |

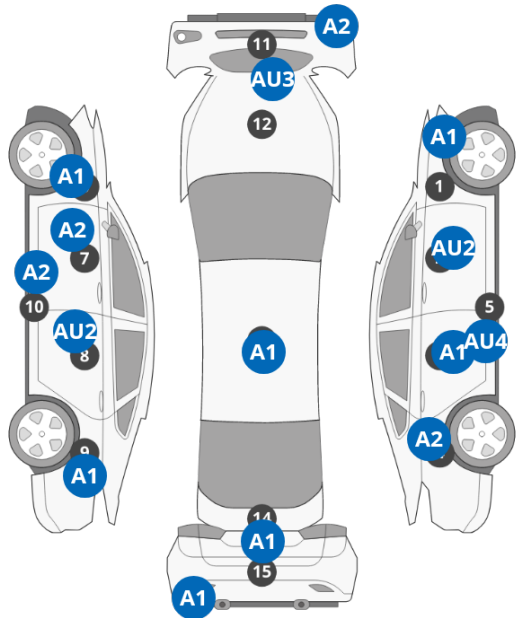
| Inspector Notes |
|---|
| with LTO plate/no warranty booklet/no tools with jack/with spare tire/no spare key/tailight cover cracked/hairline scratches on the body |
