## General Information

| Make | Toyota | Model | Vios |
| Registration No. | DBP1601 | Chassis No. | PA1B18F38R4251784 |

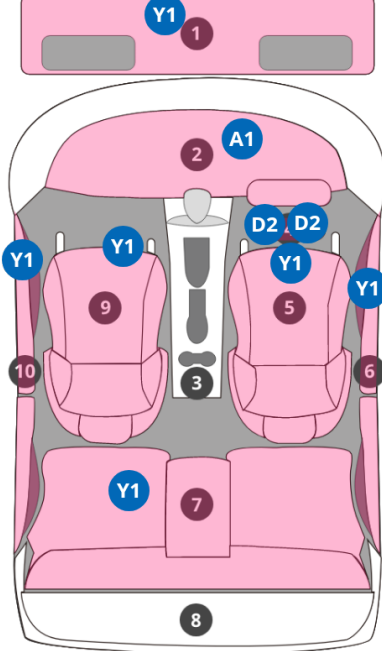
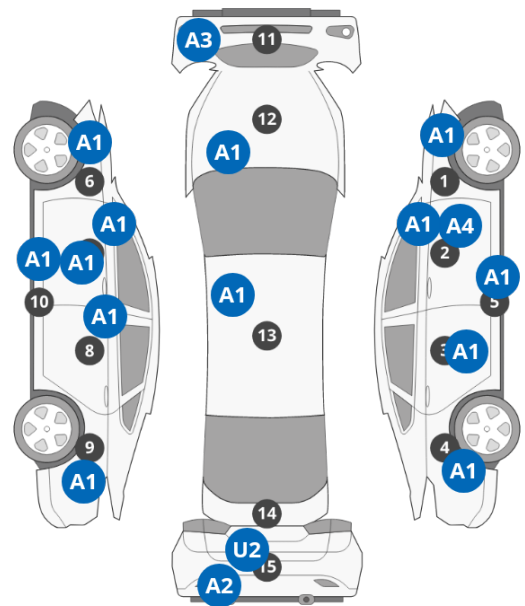
| Interior Evaluation : <b>B</b> | Exterior Evaluation : <b>C</b> |
|---|---|
| <p><b>a</b> : Cut, Fray <b>d</b> : Loose, Deformed <b>k</b> : Animal Hair <b>s</b> : Smell <b>t</b> : Cigarette Burns <b>x</b> : Defective <b>y</b> : Stain</p> | <p><b>A</b> : Scratch <b>AU</b> : Scratch &amp; Dent <b>B</b> : Modified <b>C</b> : Corrosion <b>G</b> : Stone chip <b>P</b> : Faded <b>S</b> : Rust <b>SC</b> : Rust &amp; Corrosion <b>U</b> : Dent <b>X</b> : Defective <b>Y</b> : Crack, Gap</p> |
| <p><b>Remarks</b></p> <p>(L) Front Seat - Grime - Minimal / (R) Front Seat - Grime - Minimal / Dashboard - Worn, Scratch, Cut, Crack - Minimal / Ceiling - Grime - Minimal / (L) Front Trim - Grime - Minimal / (R) Front Trim - Grime - Minimal / Rear Seat - Grime - Minimal / (L) Front Floor Mat - Worked - Small / (R) Front Floor Mat - Worked - Small</p> | <p><b>Remarks</b></p> <p>(R) Front Fender, Molding - Scratch - Minimal / (R) Front Door, Molding - Scratch - Large / (R) Mirror - Scratch - Minimal / (R) Rear Door, Molding - Scratch - Minimal / (R) Step, In-panel, Side Spoiler - Scratch - Minimal / (R) Rear Fender, Molding - Scratch - Minimal / Trunk Hood, Rear Gate - Dent - Small / Rear Bumper, Lamps, Panels - Scratch - Small / (L) Rear Fender, Molding - Scratch - Minimal / (L) Rear Door, Molding - Scratch - Minimal / (L) Front Door, Molding - Scratch - Minimal / (L) Mirror - Scratch - Minimal / (L) Front Fender, Molding - Scratch - Minimal / Front Bumper, Grille, Lamps - Scratch - Medium / Bonnet, Headlight - Scratch - Minimal / Roof - Scratch - Minimal / (L) Step, In-panel, Side Spoiler - Scratch - Minimal</p> |
