## General Information

| Make | Toyota | Model | Vios |
| Registration No. | NHU8120 | Chassis No. | PA1B18F36R4272780 |

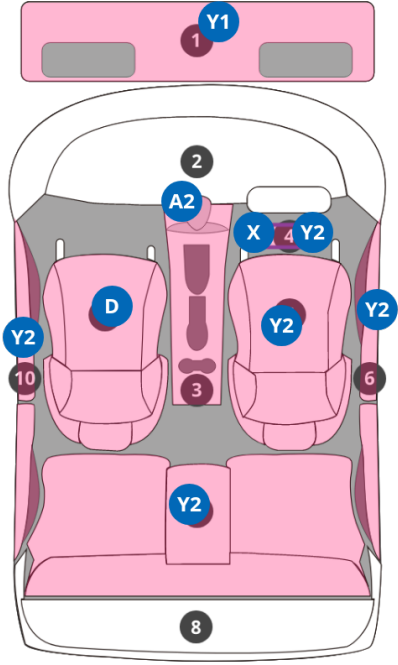
| Interior Evaluation : <b>B</b> | Exterior Evaluation : <b>E</b> |
|---|---|
| <p><b>Remarks</b><br/>(L) Front Trim - Grime - Small / (R) Front Seat - Grime - Small / (L) Front Seat - Worn - Yes / Rear Seat - Grime - Small / (L) Front Floor Mat - Missing - Yes / (R) Front Floor Mat - Grime - Small / (R) Front Trim - Grime - Small / Console, Switchs, Vents - Worn, Scratch, Cut, Crack - Small / Ceiling - Grime - Minimal</p> | <p><b>Remarks</b><br/>Trunk Hood, Rear Gate - Scratch &amp; Dent - Large / Rear Bumper, Lamps, Panels - Scratch &amp; Dent - Medium / (R) Rear Fender, Molding - Scratch &amp; Dent - Small / (R) Rear Door, Molding - Scratch - Large / (R) Step, In-panel, Side Spoiler - Scratch &amp; Dent - Large / (R) Front Door, Molding - Scratch &amp; Dent - Medium / (R) Front Fender, Molding - Scratch - Small / Front Bumper, Grille, Lamps - Scratch - Large / Bonnet, Headlight - Scratch - Minimal / (L) Front Fender, Molding - Scratch - Minimal / (L) Front Door, Molding - Scratch - Small / (L) Step, In-panel, Side Spoiler - Scratch - Small / (L) Rear Door, Molding - Scratch - Minimal / (L) Rear Fender, Molding - Scratch - Minimal / Roof - Scratch - Minimal</p> |

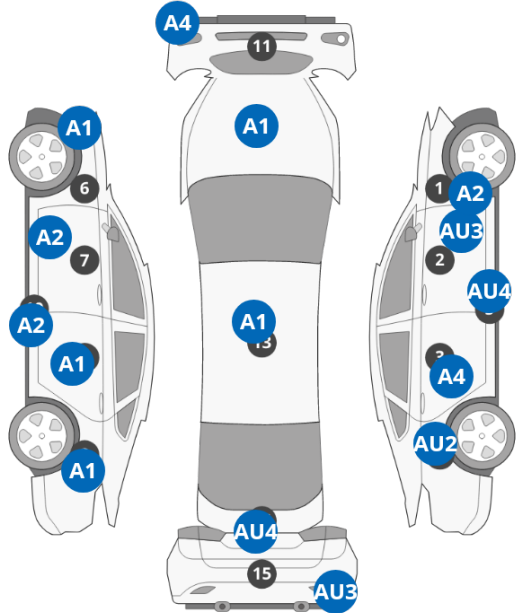
| Inspector Notes |
|---|
| <p>with LTO plate/no warranty booklet/with incomplete tools with jack/with spare tire/rough idling/suspension issue/air damper issue/gap in trunk door/scratches on taillight cover/trunk door latch/hairline scratches on the body/with spare key/with seat cover</p> |
