## General Information

| Make | Toyota | Model | Vios |

## Body / Panel Condition

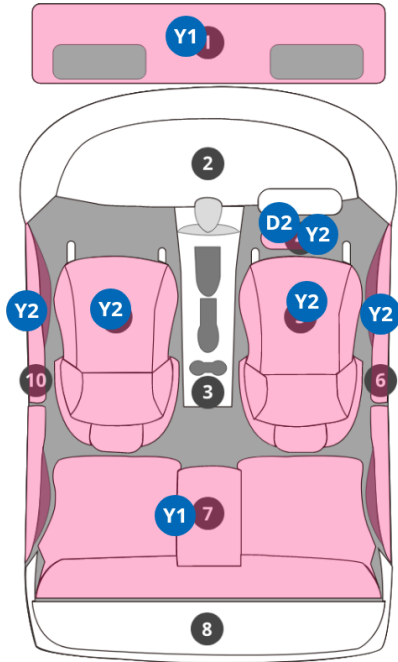
| Interior Evaluation : <b>B</b> | Exterior Evaluation : <b>D</b> |
| <p><b>Remarks</b></p> <p>(R) Front Seat - Grime - Small / (L) Front Seat - Grime - Small / Rear Seat - Grime - Minimal / (L) Front Floor Mat - Worked - Small / (R) Front Floor Mat - Grime - Small / (L) Front Trim - Grime - Small / (R) Front Trim - Grime - Small / Ceiling - Grime - Minimal</p> | <p><b>Remarks</b></p> <p>(R) Front Fender - Repair Traces - Yes / Bonnet - Repair Traces - Yes / (L) Front Fender - Repair Traces - Yes / Trunk Hood, Rear Gate - Repair Traces - Yes / Bonnet, Headlight - Scratch &amp; Dent - Medium / Front Bumper, Grille, Lamps - Scratch - Medium / Roof - Scratch &amp; Dent - Minimal / (R) Front Door, Molding - Scratch &amp; Dent - Medium / (R) Rear Door, Molding - Scratch - Medium / (R) Rear Fender, Molding - Scratch &amp; Dent - Small / Trunk Hood, Rear Gate - Modified - Small / (L) Rear Fender, Molding - Scratch &amp; Dent - Small / (L) Rear Door, Molding - Scratch &amp; Dent - Medium / (L) Front Door, Molding - Scratch &amp; Dent - Small / (L) Step, In-panel, Side Spoiler - Scratch &amp; Dent - Minimal / (R) Step, In-panel, Side Spoiler - Scratch - Minimal / (L) Front Fender, Molding - Scratch - Small / (R) Front Fender, Molding - Scratch - Small</p> |

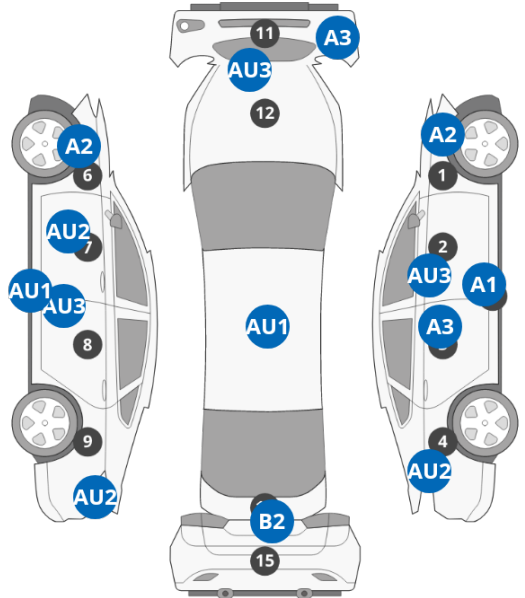
| Inspector Notes |
|---|
| <p>with LTO plate, with spare tire, with jack, with manual and warranty booklet, with reverse camera, no tools, scratches and dent on exterior, scratches on taillight and headlight, steering issue.</p> |
