## General Information

| Make | Toyota | Model | Vios |

## Body / Panel Condition

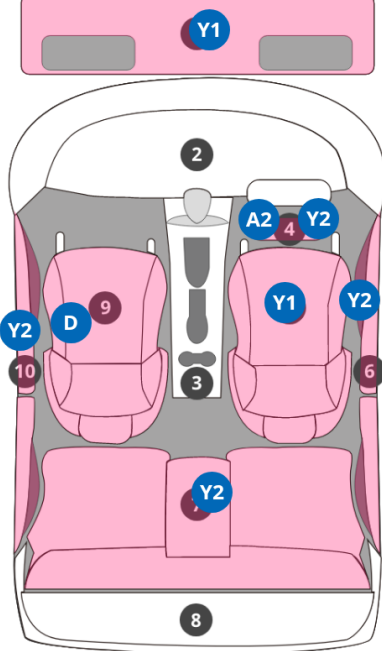
| Interior Evaluation : <b>B</b> | Exterior Evaluation : <b>C</b> |
|---|---|
| <p><b>Remarks</b><br/>(L) Front Floor Mat - Cut, Crack - Small / (R) Front Floor Mat - Grime - Small / Rear Seat - Grime - Small / (R) Front Seat - Grime - Minimal / (R) Front Trim - Grime - Small / (L) Front Seat - Worn - Yes / (L) Front Trim - Grime - Small / Ceiling - Grime - Minimal</p> | <p><b>Remarks</b><br/>(L) Rear Door, Molding - Scratch &amp; Dent - Minimal / (L) Step, In-panel, Side Spoiler - Scratch - Small / (L) Front Door, Molding - Scratch - Small / (L) Front Fender, Molding - Scratch - Minimal / (L) Rear Fender, Molding - Scratch - Small / Trunk Hood, Rear Gate - Scratch - Small / Rear Bumper, Lamps, Panels - Scratch &amp; Dent - Small / (R) Rear Fender, Molding - Scratch - Small / (R) Rear Door, Molding - Scratch - Minimal / (R) Step, In-panel, Side Spoiler - Scratch - Small / (R) Front Door, Molding - Scratch - Minimal / (R) Mirror - Scratch - Minimal / (R) Front Fender, Molding - Scratch - Small / Bonnet, Headlight - Scratch - Minimal / Front Bumper, Grille, Lamps - Scratch - Medium / Roof - Scratch - Minimal</p> |
