## General Information

| Make | Toyota | Model | Wigo |

## Body / Panel Condition

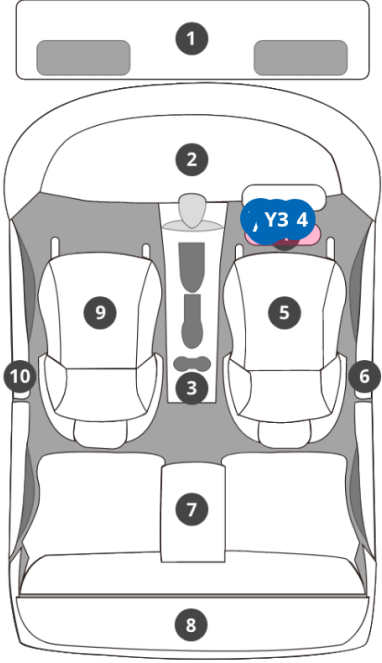
| Interior Evaluation : <span style="color: red;">C</span> | Exterior Evaluation : <span style="color: red;">D</span> |
| <b>Remarks</b><br>(R) Front Floor Mat - Worked - Large / (L) Front Floor Mat - Worked - Large / (L) Front Floor Mat - Cut, Crack - Small / Mat Other - Grime - Medium | <b>Remarks</b><br>Trunk Hood, Rear Gate - Repair Traces - Yes / (L) Front Fender, Molding - Dent - Large / Front Bumper, Grille, Lamps - Scratch & Dent - Large / (L) Step, In-panel, Side Spoiler - Scratch & Dent - Large / (L) Front Door, Molding - Scratch - Medium / (L) Rear Fender, Molding - Scratch - Small / Trunk Hood, Rear Gate - Dent - Medium / Rear Bumper, Lamps, Panels - Crack, Gap - Medium / (R) Rear Door, Molding - Scratch & Dent - Small / (R) Front Door, Molding - Scratch & Dent - Small / (R) Rear Fender, Molding - Dent - Minimal |
