## General Information

| Make | Toyota | Model | Vios |

## Body / Panel Condition

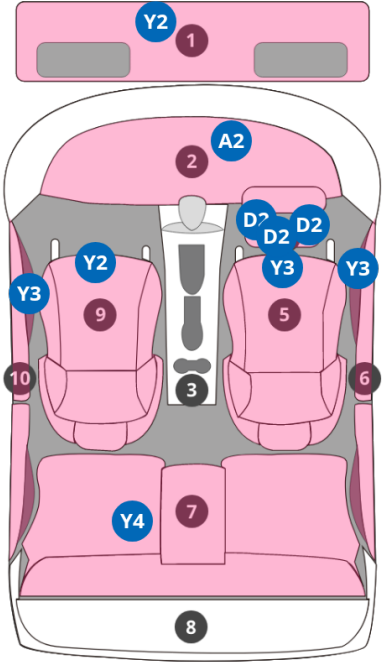
| Interior Evaluation : <span style="color: red;">C</span> | Exterior Evaluation : <span style="color: red;">C</span> |
|---|---|
| <p><b>Remarks</b><br/>Dashboard - Worn, Scratch, Cut, Crack - Small / (R)<br/>Front Seat - Grime - Medium / (L) Front Seat - Grime - Small / Rear Seat - Grime - Large / (R) Front Trim - Grime - Medium / (L) Front Trim - Grime - Medium / Ceiling - Grime - Small / (L) Front Floor Mat - Worked - Small / (R) Front Floor Mat - Worked - Small / Mat Other - Worked - Small</p> | <p><b>Remarks</b><br/>(R) Front Fender, Molding - Scratch - Minimal / (R) Front Door, Molding - Scratch - Minimal / (R) Rear Door, Molding - Scratch - Minimal / (R) Step, In-panel, Side Spoiler - Scratch - Minimal / (R) Rear Fender, Molding - Scratch - Minimal / Rear Bumper, Lamps, Panels - Dent - Small / (L) Rear Fender, Molding - Scratch - Minimal / (L) Rear Door, Molding - Scratch - Small / (L) Front Door, Molding - Scratch - Minimal / (L) Front Fender, Molding - Scratch - Minimal / (L) Step, In-panel, Side Spoiler - Scratch - Minimal / Front Bumper, Grille, Lamps - Scratch - Medium / Bonnet, Headlight - Scratch - Minimal / Roof - Dent - Small / Trunk Hood, Rear Gate - Crack, Gap - Medium</p> |

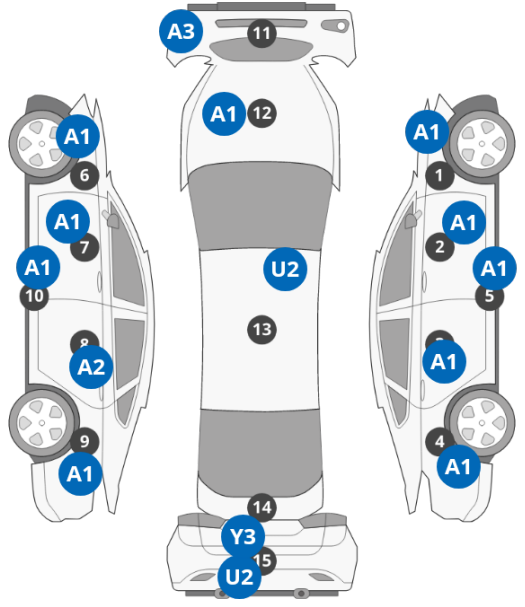
| Inspector Notes |
|---|
| with Ito plate/with jack no tools/with hairlines scratches on the body/with spare tire/with reverse camera/without spare tire |
