## General Information

| Make | Toyota | Model | Vios |

## Body / Panel Condition

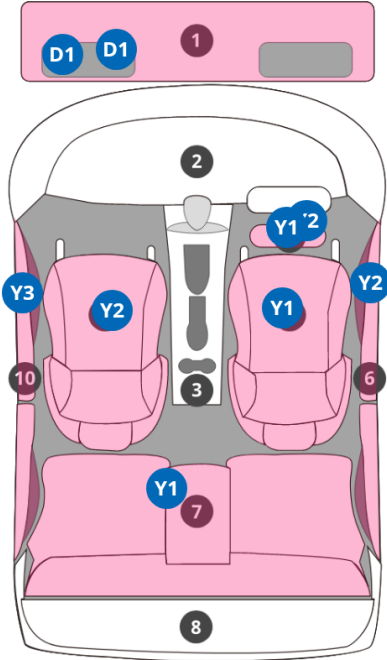
| Interior Evaluation : <b>B</b> | Exterior Evaluation : <b>E</b> |
| <p><b>Remarks</b><br/>(L) Front Floor Mat - Grime - Small / (R) Front Floor Mat - Grime - Minimal / Rear Seat - Grime - Minimal / (L) Front Seat - Grime - Small / (R) Front Seat - Grime - Minimal / (L) Front Trim - Grime - Medium / (R) Front Trim - Grime - Small / Ceiling - Crinkle - Minimal / Sunvisor, Sunglass Holder - Crinkle - Minimal</p> | <p><b>Remarks</b><br/>(R) Front Fender - Repair Traces - Yes / Bonnet - Repair Traces - Yes / (L) Front Fender - Repair Traces - Yes / Trunk Hood, Rear Gate - Repair Traces - Yes / (L) Front Door, Molding - Repair mark - Yes / (L) Front Door, Molding - Scratch - Small / (L) Rear Door, Molding - Scratch &amp; Dent - Minimal / (L) Rear Door, Molding - Repair mark - Yes / (L) Step, In-panel, Side Spoiler - Repair mark - Yes / (L) Rear Fender, Molding - Scratch &amp; Dent - Minimal / Trunk Hood, Rear Gate - Scratch - Small / Rear Bumper, Lamps, Panels - Scratch - Small / Rear Bumper, Lamps, Panels - Modified - Medium / (R) Rear Fender, Molding - Scratch - Medium / (R) Rear Door, Molding - Scratch &amp; Dent - Small / (R) Step, In-panel, Side Spoiler - Scratch - Medium / (R) Front Door, Molding - Scratch - Medium / (R) Front Fender, Molding - Scratch - Medium / Front Bumper, Grille, Lamps - Modified - Medium / Bonnet, Headlight - Scratch &amp; Dent - Small / (L) Front Fender, Molding - Scratch &amp; Dent - Small / Roof - Scratch &amp; Dent - Small</p> |

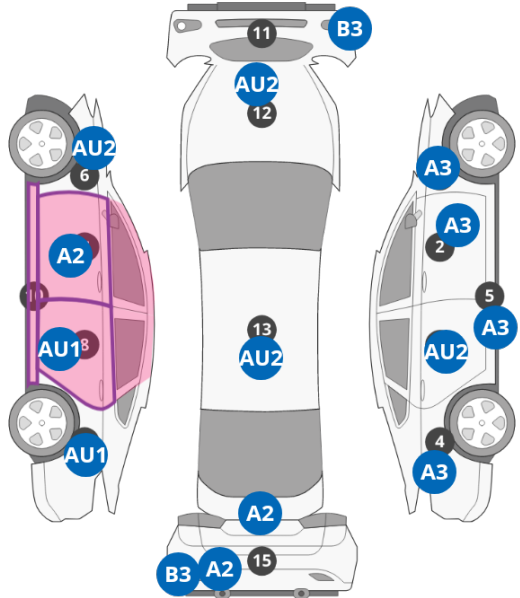
| Inspector Notes |
|---|
| with LTO plate, with spare tire, with reverse camera, no tools and jack, warranty and manual booklet, no spare key, scratches and dent on exterior, scratches on taillight and headlight, taillight crack issue, |
