## General Information

| Make | Toyota | Model | Avanza |
| Registration No. | FAT6412 | Chassis No. | MHFAA1BY3S0045421 |

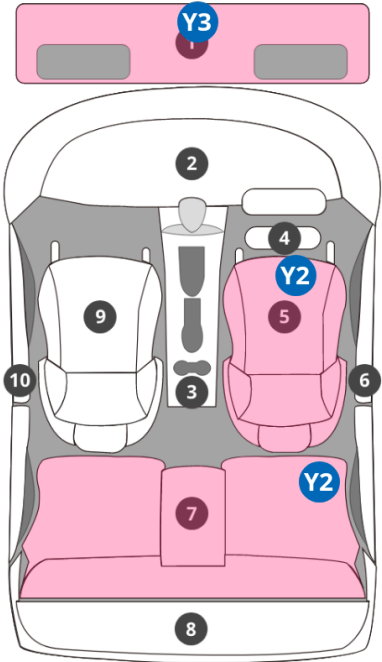
| Interior Evaluation : <b>B</b> | Exterior Evaluation : <b>C</b> |
|---|---|
| <b>Remarks</b><br>Ceiling - Grime - Medium / (R) Front Seat - Grime - Small / Rear Seat - Grime - Small | <b>Remarks</b><br>(R) Rear Door, Molding - Scratch & Dent - Large / (R) Step, In-panel, Side Spoiler - Scratch & Dent - Large / (R) Rear Fender, Molding - Scratch & Dent - Large / (L) Rear Door, Molding - Scratch - Minimal / (L) Front Door, Molding - Scratch & Dent - Medium / Front Bumper, Grille, Lamps - Scratch & Dent - Large |

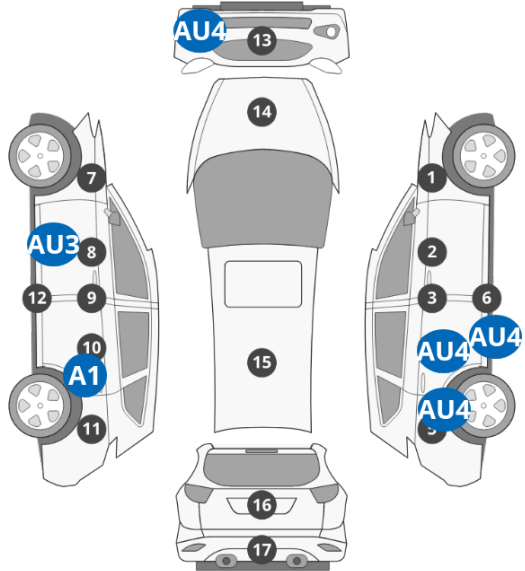
no lto plates, no warranty booklet, no spare tire, no jack, incomplete tools, with PMS alarm, with hairline scratches in the body, with stain/paint droplets in the body
