## General Information

| Make | Toyota | Model | Vios |

## Body / Panel Condition

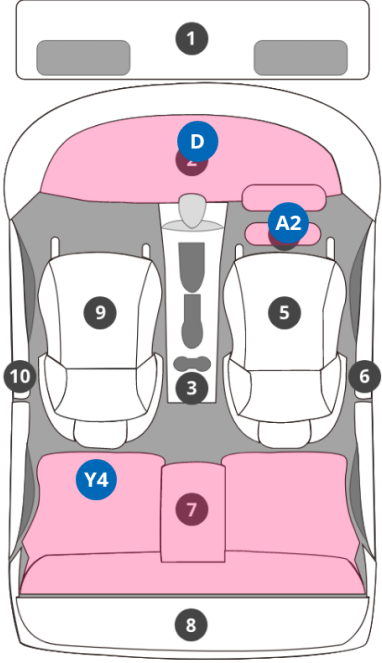
| Interior Evaluation : <b>C</b> | Exterior Evaluation : <b>E</b> |
|---|---|
| <b>Remarks</b><br>(L) Front Floor Mat - Cut, Crack - Small / Dashboard - Traces of Adhesive Tape - Yes / Rear Seat - Grime - Large | <b>Remarks</b><br>(R) Front Fender - Repair Traces - Yes / Bonnet - Repair Traces - Yes / Bonnet, Headlight - Scratch & Dent - Large / Rear Bumper, Lamps, Panels - Scratch - Medium / Trunk Hood, Rear Gate - Scratch - Small / (R) Rear Fender, Molding - Dent - Small / (R) Rear Door, Molding - Scratch - Large / (R) Front Door, Molding - Scratch - Large / (L) Rear Door, Molding - Scratch - Small / (L) Front Door, Molding - Scratch - Medium / Front Bumper, Grille, Lamps - Scratch & Dent - Large |

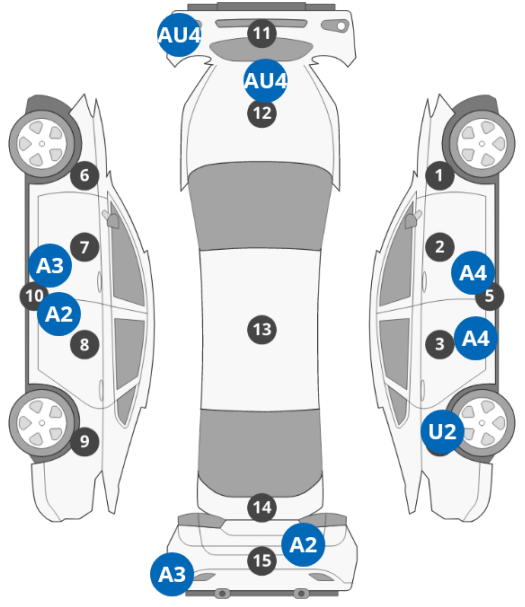
| Inspector Notes |
|---|
| with LTO plate/with spare tire/with jack and tools/with warranty booklets/ left tail light and headlights damages |
