## General Information

| Make | Toyota | Model | Wigo |

## Overall Evaluation :

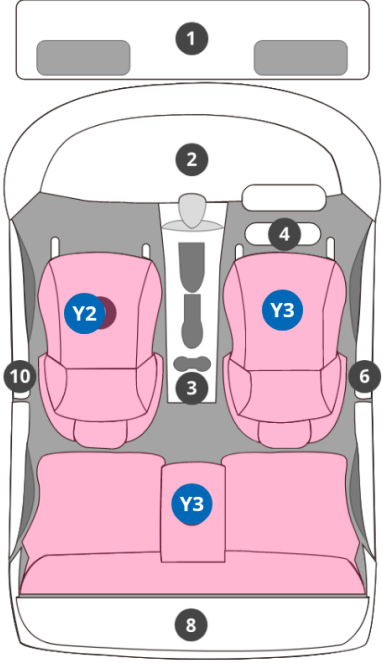
| Interior Evaluation : <b>B</b> | Exterior Evaluation : <b>E</b> |
|---|---|
| <b>Remarks</b><br>(R) Front Seat - Grime - Medium / (L) Front Seat - Grime - Small / Rear Seat - Grime - Medium | <b>Remarks</b><br>(R) Front Fender, Molding - Scratch - Medium / (R) Mirror - Scratch - Small / (R) Front Door, Molding - Scratch & Dent - Large / (R) Step, In-panel, Side Spoiler - Scratch - Small / (R) Rear Door, Molding - Scratch - Medium / (R) Rear Fender, Molding - Scratch - Medium / (L) Front Fender, Molding - Scratch - Medium / (L) Front Door, Molding - Scratch - Large / (L) Step, In-panel, Side Spoiler - Scratch - Small / (L) Rear Door, Molding - Scratch - Large / (L) Rear Fender, Molding - Scratch - Small / Front Bumper, Grille, Lamps - Scratch & Dent - Medium / Bonnet, Headlight - Scratch - Minimal / Trunk Hood, Rear Gate - Scratch - Minimal / Rear Bumper, Lamps, Panels - Scratch - Minimal |
