## General Information

| Make | Toyota | Model | Wigo |

## Body / Panel Condition

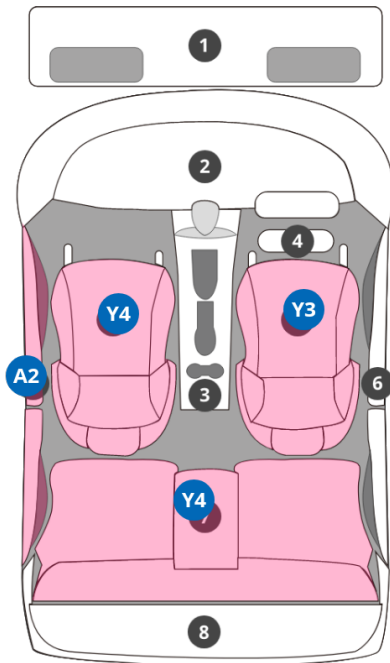
| Interior Evaluation : <b>C</b> | Exterior Evaluation : <b>E</b> |
|---|---|
| <b>Remarks</b><br>(R) Front Seat - Grime - Medium / (L) Front Seat - Grime - Large / Rear Seat - Grime - Large / (L) Front Trim - Cut, Crack - Small | <b>Remarks</b><br>(R) Front Fender, Molding - Scratch - Medium / (R) Mirror - Scratch - Small / (R) Front Door, Molding - Scratch - Medium / (R) Rear Door, Molding - Scratch - Medium / (R) Step, In-panel, Side Spoiler - Scratch & Dent - Large / (R) Rear Fender, Molding - Scratch - Small / (L) Front Fender, Molding - Scratch & Dent - Medium / (L) Mirror - Scratch - Minimal / (L) Front Door, Molding - Scratch - Small / (L) Rear Door, Molding - Scratch - Small / (L) Rear Fender, Molding - Scratch - Small / (L) Step, In-panel, Side Spoiler - Scratch - Minimal / Front Bumper, Grille, Lamps - Scratch & Dent - Large / Bonnet, Headlight - Scratch - Small / Trunk Hood, Rear Gate - Scratch - Small / Rear Bumper, Lamps, Panels - Scratch & Dent - Medium |
