## General Information

| Make | Toyota | Model | Vios |
| Registration No. | KAU8710 | Chassis No. | PA1B18F34S4291740 |

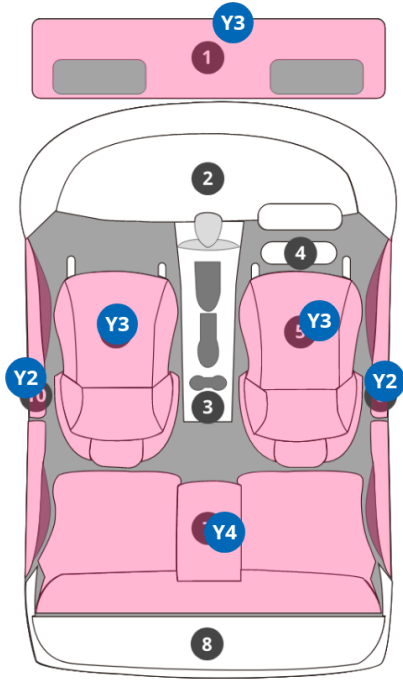
| Interior Evaluation : <span style="color: red;">C</span> | Exterior Evaluation : <span style="color: red;">E</span> |
|---|---|
| <b>Remarks</b><br>(R) Front Seat - Grime - Medium / (L) Front Seat - Grime - Medium / Rear Seat - Grime - Large / (L) Front Trim - Grime - Small / (R) Front Trim - Grime - Small / Ceiling - Grime - Medium | <b>Remarks</b><br>(R) Front Fender, Molding - Repair mark - Difference in Color / (R) Front Door, Molding - Scratch & Dent - Medium / (R) Rear Door, Molding - Scratch - Small / (R) Rear Fender, Molding - Scratch - Medium / (L) Front Fender, Molding - Crack, Gap - Medium / (L) Front Door, Molding - Scratch & Dent - Medium / (L) Rear Door, Molding - Scratch - Large / (L) Rear Fender, Molding - Scratch - Small / Front Bumper, Grille, Lamps - Repair mark - Difference in Color / Front Bumper, Grille, Lamps - Crack, Gap - Medium / Bonnet, Headlight - Dent - Medium / Trunk Hood, Rear Gate - Rust, Corrosion - Minimal / Rear Bumper, Lamps, Panels - Repair mark - Difference in Color / Rear Bumper, Lamps, Panels - Dent - Medium |

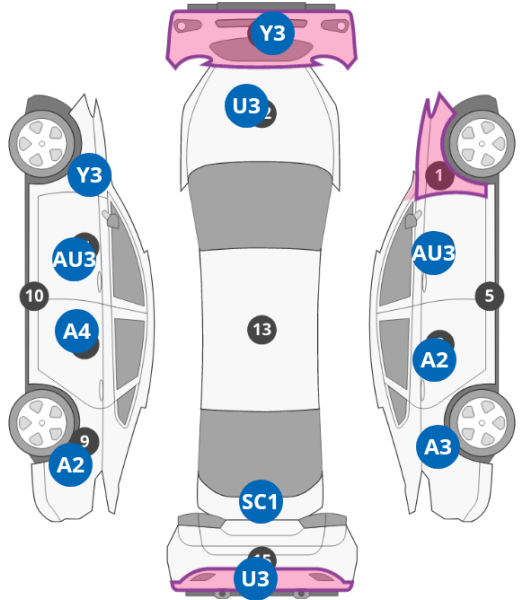
With LTO plate, with warranty booklet, with tools, with jack, no seat cover, with spare tire, with spare key 2pcs, with hairline scratches, with areas which are repaired (difference in color).
