## General Information

| Make | Toyota | Model | Vios |
| Registration No. | JAS8234 | Chassis No. | PA1B18F34R4274575 |

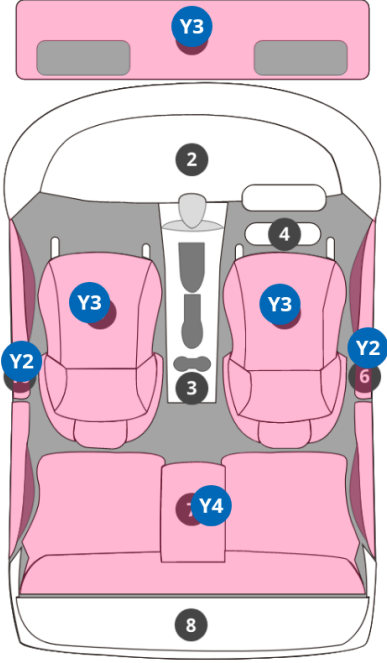
| Interior Evaluation : <span style="color: red;">C</span> | Exterior Evaluation : <span style="color: red;">C</span> |
| <p><b>Remarks</b><br/>(R) Front Seat - Grime - Medium / (L) Front Seat - Grime - Medium / (L) Front Trim - Grime - Small / (R) Front Trim - Grime - Small / Rear Seat - Grime - Large / Ceiling - Grime - Medium</p> | <p><b>Remarks</b><br/>(R) Front Fender, Molding - Crack, Gap - Medium / (R) Front Door, Molding - Scratch - Small / (R) Rear Door, Molding - Scratch &amp; Dent - Small / (R) Rear Fender, Molding - Scratch - Medium / (R) Step, In-panel, Side Spoiler - Dent - Medium / (L) Front Fender, Molding - Scratch - Minimal / (L) Mirror - Scratch - Minimal / (L) Front Door, Molding - Scratch - Small / (L) Rear Door, Molding - Scratch - Minimal / (L) Rear Fender, Molding - Scratch - Minimal / Front Bumper, Grille, Lamps - Scratch &amp; Dent - Medium / Bonnet, Headlight - Scratch - Minimal / Trunk Hood, Rear Gate - Scratch - Minimal / Rear Bumper, Lamps, Panels - Scratch - Minimal</p> |
