## General Information

| Make | Toyota | Model | Vios |
| YOM | 2021 | Mileage | 40,178 |
| Registration No. | NET4677 | Chassis No. | PA1B18F35M4146810 |

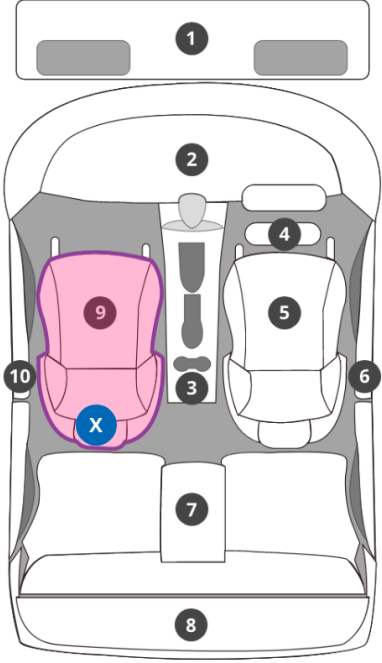
| <b>Interior Evaluation :</b> <b>B</b> | <b>Exterior Evaluation :</b> <b>D</b> |
| <b>Remarks</b><br>(L) Front Seat - Missing - Yes | <b>Remarks</b><br>Trunk Hood, Rear Gate - Dent - Small / Rear Bumper, Lamps, Panels - Scratch - Medium / (R) Rear Fender, Molding - Dent - Small / (R) Rear Door, Molding - Scratch & Dent - Large / (R) Step, In-panel, Side Spoiler - Scratch & Dent - Large / (R) Front Door, Molding - Scratch - Medium / (R) Front Fender, Molding - Dent - Small / Front Bumper, Grille, Lamps - Dent - Small / (L) Front Fender, Molding - Scratch - Small / (L) Front Door, Molding - Scratch - Minimal / (L) Rear Door, Molding - Scratch - Medium / (L) Rear Fender, Molding - Scratch - Small |
