## General Information

| Make | Toyota | Model | Vios |
| YOM | 2025 | Odo Meter Reading | 35,475 |

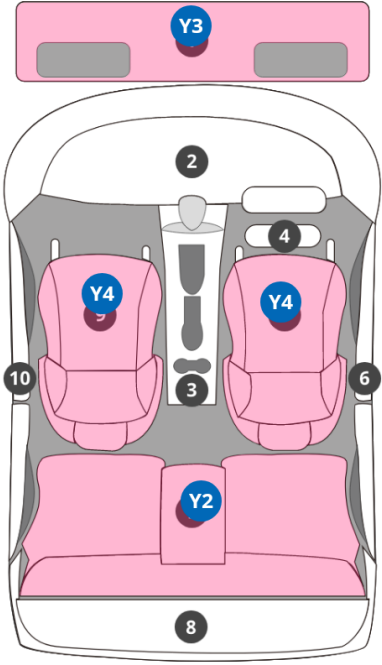
| Interior Evaluation : <span style="color: red;">C</span> | Exterior Evaluation : <span style="color: red;">E</span> |
| <b>Remarks</b><br>(R) Front Seat - Grime - Large / (L) Front Seat - Grime - Large / Rear Seat - Grime - Small / Ceiling - Grime - Medium | <b>Remarks</b><br>(R) Front Fender, Molding - Scratch & Dent - Large / (R) Front Door, Molding - Scratch - Small / (R) Rear Door, Molding - Scratch - Medium / (R) Step, In-panel, Side Spoiler - Scratch & Dent - Large / (R) Rear Fender, Molding - Scratch & Dent - Medium / (L) Front Fender, Molding - Scratch - Medium / (L) Front Door, Molding - Scratch - Medium / (L) Rear Door, Molding - Scratch - Medium / (L) Rear Fender, Molding - Scratch - Small / Front Bumper, Grille, Lamps - Scratch - Large / Bonnet, Headlight - Scratch & Dent - Small / Trunk Hood, Rear Gate - Scratch - Small / Rear Bumper, Lamps, Panels - Scratch & Dent - Large / (L) Front Wheel, Cover - Cap Missing - Yes |
