## General Information

| Make | Toyota | Model | Vios |

## Body / Panel Condition

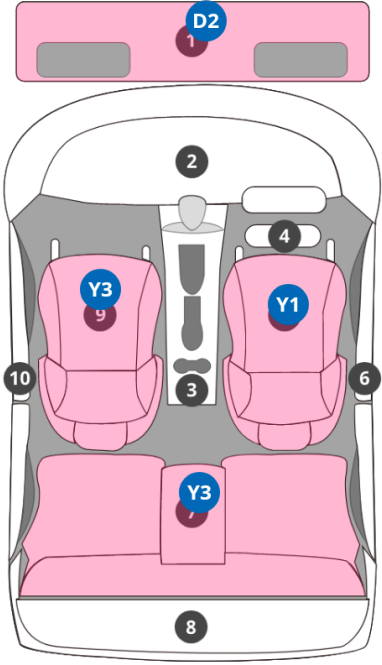
| Interior Evaluation : <b>B</b> | Exterior Evaluation : <b>E</b> |
|---|---|
| <b>Remarks</b><br>(R) Front Seat - Grime - Minimal / Rear Seat - Grime - Medium / Ceiling - Crinkle - Small / (L) Front Seat - Grime - Medium | <b>Remarks</b><br>(R) Front Fender, Molding - Scratch - Small / (R) Front Door, Molding - Scratch - Small / (R) Rear Door, Molding - Scratch & Dent - Large / (R) Rear Fender, Molding - Scratch - Medium / (L) Front Fender, Molding - Scratch - Medium / (L) Front Door, Molding - Scratch - Large / (L) Rear Door, Molding - Scratch - Medium / (L) Rear Fender, Molding - Scratch - Small / Front Bumper, Grille, Lamps - Scratch - Large / Bonnet, Headlight - Scratch - Minimal / Rear Bumper, Lamps, Panels - Scratch - Medium |
