## General Information

| Make | Suzuki | Model | Ertiga |

## Body / Panel Condition

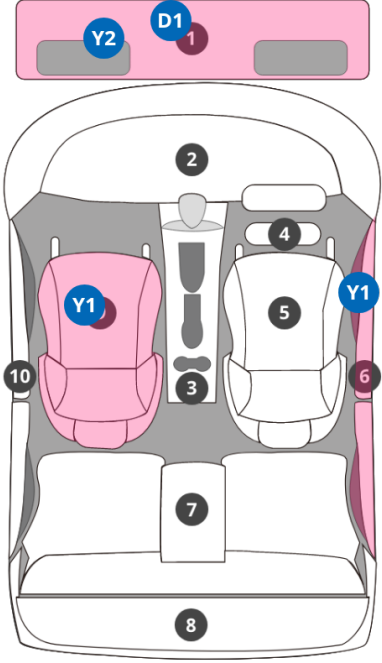
| Interior Evaluation : <b>A</b> | Exterior Evaluation : <b>C</b> |
|---|---|
| <b>Remarks</b><br>(L) Front Seat - Grime - Minimal / Ceiling - Crinkle - Minimal / Sunvisor, Sunglass Holder - Grime - Small / (R) Front Trim - Grime - Minimal | <b>Remarks</b><br>Overall Exterior - Faded(Color, Gloss) - Yes / (L) Rear Door, Molding - Scratch - Small / (L) Front Door, Molding - Scratch - Minimal / Bonnet, Headlight - Scratch - Minimal / Front Bumper, Grille, Lamps - Scratch - Minimal / (R) Front Fender, Molding - Scratch - Minimal / (R) Front Door, Molding - Scratch - Minimal / (R) Rear Door, Molding - Scratch - Minimal / (R) Rear Fender, Molding - Scratch - Minimal / Trunk Hood, Rear Gate - Scratch - Minimal / Rear Bumper, Lamps, Panels - Scratch - Minimal |

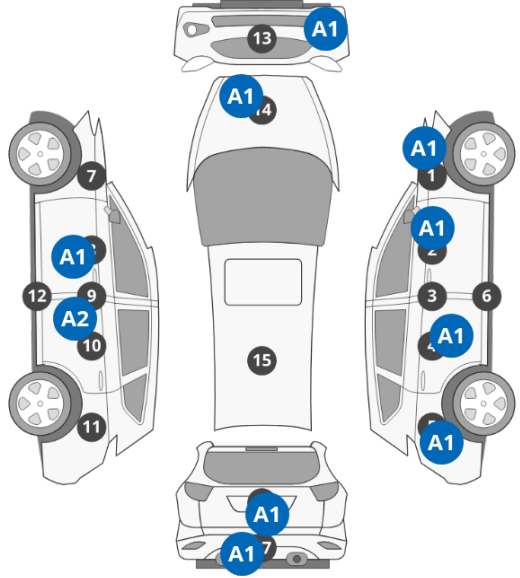
with LTO plate, with spare tire and key, with warranty and manual booklet, with reverse camera, with jack and tools, minor scratches on exterior, slight fade paint, minor scratches on taillight and headlight.
