## General Information

| Make | Nissan | Model | NV350 |
| Registration No. | GB07939 | Chassis No. | JN1LC4E26Z0060237 |

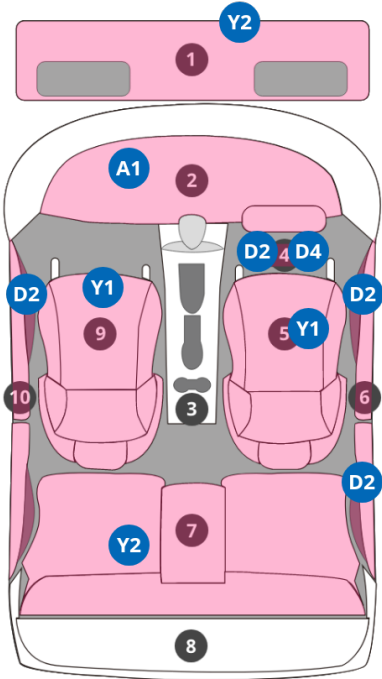
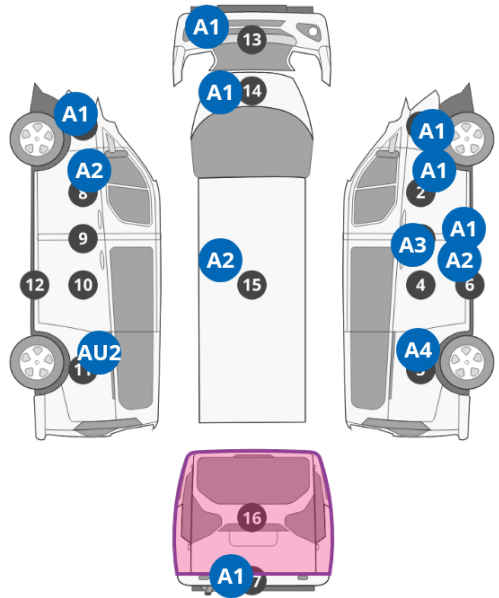
| Interior Evaluation : <span style="color: red;">C</span> | Exterior Evaluation : <span style="color: red;">C</span> |
|---|---|
| <b>Remarks</b><br>Dashboard - Worn, Scratch, Cut, Crack - Minimal / (L)<br>Front Seat - Grime - Minimal / (R) Front Seat - Grime - Minimal / (L) Front Floor Mat - Worked - Small / Ceiling - Grime - Small / Mat Other - Worked - Large / Rear Seat - Grime - Small / (L) Front Trim - Worked - Small / (R) Front Trim - Worked - Small / (R) Rear Trim - Worked - Small | <b>Remarks</b><br>Trunk Hood, Rear Gate - Repair Traces - Yes / (R) Front Fender, Molding - Scratch - Minimal / (R) Front Door, Molding - Scratch - Minimal / (R) Center Panel - Scratch - Minimal / (R) Rear Door, Molding - Scratch - Medium / (R) Rear Fender, Molding - Scratch - Large / Trunk Hood, Rear Gate - Repair mark - Yes / Rear Bumper, Lamps, Panels - Scratch - Minimal / (L) Rear Fender, Molding - Scratch & Dent - Small / (L) Front Door, Molding - Scratch - Small / (L) Front Fender, Molding - Scratch - Minimal / Front Bumper, Grille, Lamps - Scratch - Minimal / Front Panel - Scratch - Minimal / Roof - Scratch - Small / (R) Step, In-panel, Side Spoiler - Scratch - Small |

with Ito plate/with warranty booklet/with jack and tools/with spare tire/with spare key/with dent and hairlines scratches on the body/with stain on the exterior/without reverse camera/possible flooding
