## General Information

| Make | Toyota | Model | Vios |
| YOM | 2020 | Mileage | 32,030 |
| Registration No. | EAE9763 | Chassis No. | PA1B18F31L4119974 |

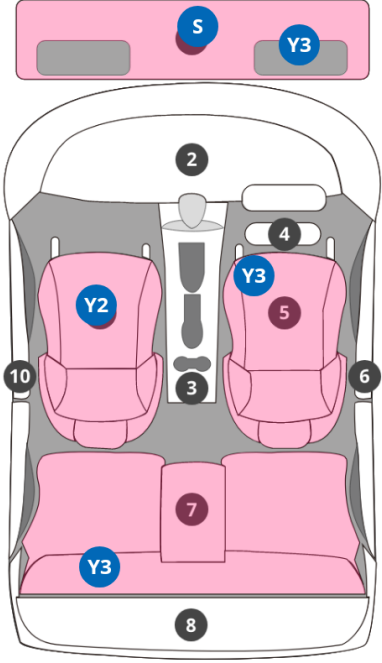
| Interior Evaluation : <b>B</b> | Exterior Evaluation : <b>E</b> |
|---|---|
| <p><b>Remarks</b><br/>Sunvisor, Sunglass Holder - Grime - Medium / (R) Front Seat - Grime - Medium / Rear Seat - Grime - Medium / (L) Front Seat - Grime - Small / Overall Interior - Smell - Yes</p> | <p><b>Remarks</b><br/>(R) Front Fender - Repair Traces - Yes / Bonnet - Repair Traces - Yes / (L) Front Fender - Repair Traces - Yes / Member (Bolted) - Dent - Yes / Front Bumper, Grille, Lamps - Scratch &amp; Dent - Large / (R) Front Door, Molding - Scratch &amp; Dent - Large / (R) Step, In-panel, Side Spoiler - Scratch &amp; Dent - Large / (R) Rear Door, Molding - Repair mark - Yes / (R) Rear Door, Molding - Scratch - Small / (R) Rear Fender, Molding - Scratch &amp; Dent - Small / Rear Bumper, Lamps, Panels - Scratch &amp; Dent - Large / (L) Rear Fender, Molding - Scratch &amp; Dent - Large / (L) Step, In-panel, Side Spoiler - Dent - Medium / (L) Rear Door, Molding - Scratch - Small / Bonnet, Headlight - Scratch - Medium / Trunk Hood, Rear Gate - Scratch &amp; Dent - Medium / (L) Front Door, Molding - Scratch - Small</p> |
