## General Information

| Make | Toyota | Model | Hiace |

## Body / Panel Condition

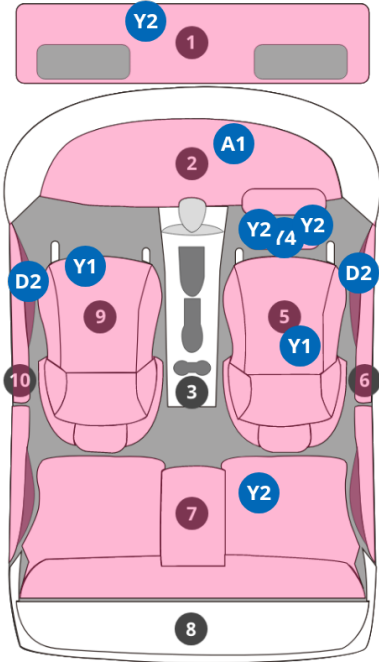
| Interior Evaluation : <span style="color: red;">C</span> | Exterior Evaluation : <span style="color: red;">E</span> |
|---|---|
| <b>Remarks</b><br>Mat Other - Grime - Large / (R) Front Floor Mat - Grime - Small / (L) Front Floor Mat - Grime - Small / (L) Front Seat - Grime - Minimal / (R) Front Seat - Grime - Minimal / Dashboard - Worn, Scratch, Cut, Crack - Minimal / Ceiling - Grime - Small / (L) Front Trim - Worked - Small / (R) Front Trim - Worked - Small / Rear Seat - Grime - Small | <b>Remarks</b><br>Front Windshield - Damaged - Large / (R) Front Fender, Molding - Scratch - Minimal / (R) Front Door, Molding - Scratch - Small / (R) Rear Door, Molding - Repair mark - Difference in Color / (R) Rear Fender, Molding - Scratch - Small / (R) Step, In-panel, Side Spoiler - Repair mark - Difference in Color / Trunk Hood, Rear Gate - Dent - Small / Rear Bumper, Lamps, Panels - Dent - Small / (L) Step, In-panel, Side Spoiler - Scratch & Dent - Medium / (L) Rear Door, Molding - Scratch - Small / (L) Front Door, Molding - Scratch - Small / (L) Front Fender, Molding - Scratch & Dent - Medium / Bonnet, Headlight - Dent - Small / Front Bumper, Grille, Lamps - Scratch - Minimal / Roof - Scratch - Minimal |

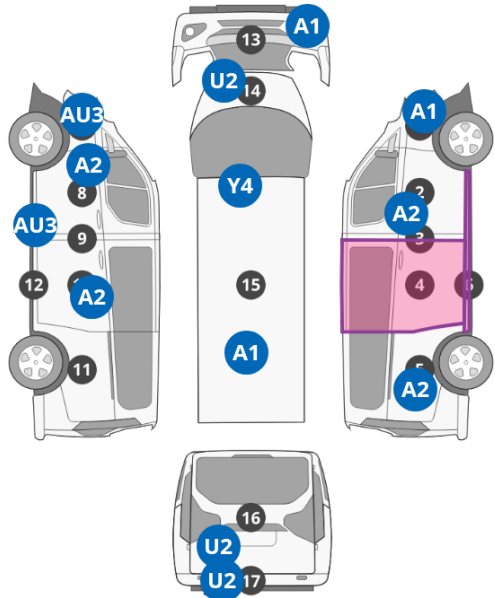
with Ito plate/with warranty booklet/with spare tire/with tools and jack/with hairlines scratches on the body/tail light damage/without spare key/with reverse camera/power window master switch issue/windshield damage
