## General Information

| Make | Toyota | Model | Hilux Tamaraw |

## Body / Panel Condition

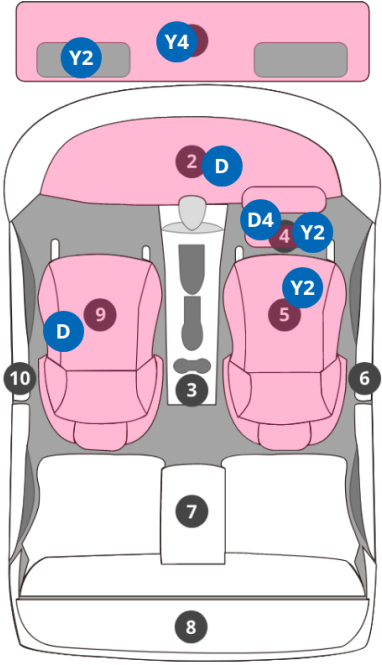
| Interior Evaluation : <span style="color: red;">C</span> | Exterior Evaluation : <span style="color: red;">E</span> |
|---|---|
| <b>Remarks</b><br>(R) Front Floor Mat - Grime - Small / (R) Front Seat - Grime - Small / Ceiling - Grime - Large / Sunvisor, Sunglass Holder - Grime - Small / (L) Front Floor Mat - Worked - Large / (L) Front Seat - Worn - Yes / Dashboard - Traces of Adhesive Tape - Yes | <b>Remarks</b><br>Cargo Bed Floor - Repair mark - Yes / Rear Bumper, Lamps, Panels - Repair mark - Yes / (L) Front Fender, Molding - Scratch - Small / (L) Front Door, Molding - Scratch & Dent - Medium / (L) Step, In-panel, Side Spoiler - Scratch - Small / (L) Side Gate - Scratch - Medium / Rear Bumper, Lamps, Panels - Scratch - Medium / Rear Gate - Scratch - Small / Cargo Bed Floor - Scratch - Large / (R) Side Gate - Scratch & Dent - Large / (R) Center Panel - Scratch - Minimal / (R) Front Door, Molding - Scratch - Small / (R) Step, In-panel, Side Spoiler - Scratch - Small / (R) Front Fender, Molding - Scratch - Minimal / Bonnet, Headlight - Scratch - Minimal / Front Bumper, Grille, Lamps - Scratch - Small / Roof - Scratch & Dent - Small |
