## General Information

| Make | Toyota | Model | Hilux Tamaraw |
| YOM | 2025 | Odo Meter Reading | 31,471 |
| Registration No. | NEZ8414 | Chassis No. | PAHACACA4S6427192 |

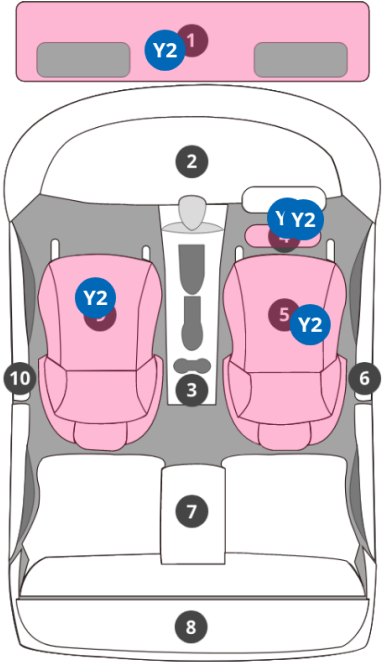
| Interior Evaluation : <b>B</b> | Exterior Evaluation : <b>D</b> |
| <b>Remarks</b><br>(L) Front Floor Mat - Grime - Medium / (R) Front Floor Mat - Grime - Small / (L) Front Seat - Grime - Small / (R) Front Seat - Grime - Small / Ceiling - Grime - Small | <b>Remarks</b><br>Bonnet - Repair Traces - Yes / (R) Side Gate - Scratch & Dent - Small / Roof - Dent - Medium / (R) Front Door, Molding - Scratch - Medium / (R) Front Fender, Molding - Scratch & Dent - Small / Bonnet, Headlight - Scratch & Dent - Small / (L) Front Fender, Molding - Scratch & Dent - Small / (L) Front Door, Molding - Scratch & Dent - Small / (L) Step, In-panel, Side Spoiler - Scratch & Dent - Minimal / (R) Step, In-panel, Side Spoiler - Scratch - Minimal / (L) Side Gate - Scratch & Dent - Small / Rear Gate - Scratch & Dent - Small / Cargo Bed Floor - Scratch - Medium / Cab Back Panel - Scratch - Small / Rear Bumper, Lamps, Panels - Scratch - Medium / Front Bumper, Grille, Lamps - Scratch - Small |

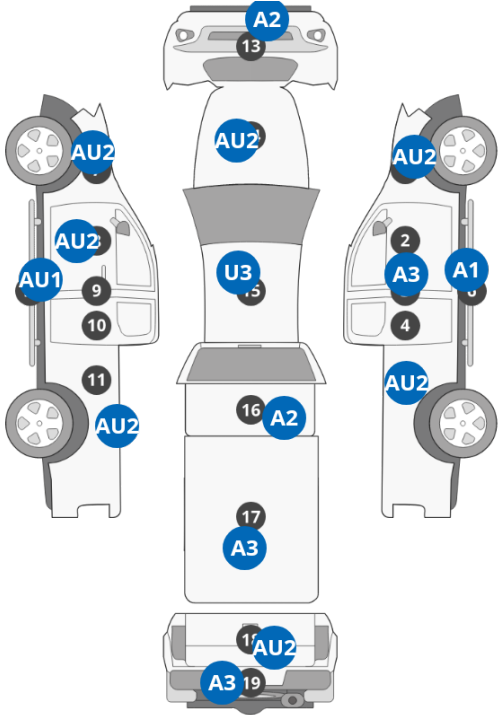
with LTO plate, with spare tire and key, with jack, with manual and warranty booklet, no reverse camera, scratches and dent on exterior, scratches in taillight and headlight.
