## General Information

| Make | Toyota | Model | Hilux Tamaraw |

## Body / Panel Condition

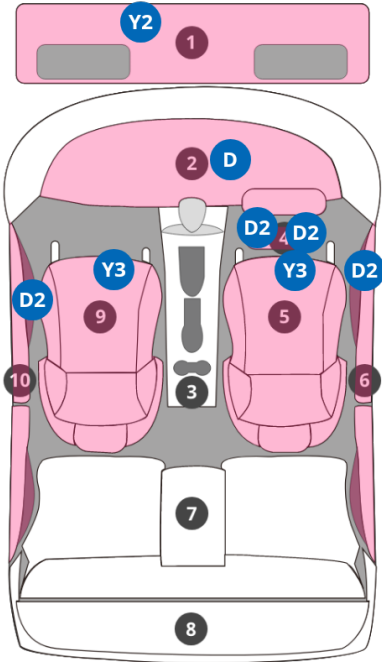
| Interior Evaluation : <span style="color: red;">C</span> | Exterior Evaluation : <span style="color: red;">C</span> |
|---|---|
| <b>Remarks</b><br>Dashboard - Traces of Adhesive Tape - Yes / (L) Front Floor Mat - Worked - Small / (R) Front Floor Mat - Worked - Small / Ceiling - Grime - Small / (L) Front Trim - Worked - Small / (R) Front Trim - Worked - Small / (R) Front Seat - Grime - Medium / (L) Front Seat - Grime - Medium | <b>Remarks</b><br>(R) Front Fender, Molding - Scratch - Minimal / (R) Front Door, Molding - Dent - Large / (R) Step, In-panel, Side Spoiler - Scratch - Minimal / (R) Side Gate - Scratch & Dent - Small / Cargo Bed Floor - Scratch & Dent - Medium / Rear Gate - Scratch - Minimal / (L) Side Gate - Scratch - Minimal / (L) Front Door, Molding - Scratch - Minimal / (L) Mirror - Scratch - Minimal / (L) Front Fender, Molding - Scratch - Minimal / (L) Step, In-panel, Side Spoiler - Scratch - Minimal / Bonnet, Headlight - Scratch - Minimal / Front Bumper, Grille, Lamps - Scratch - Minimal / Roof - Dent - Medium |

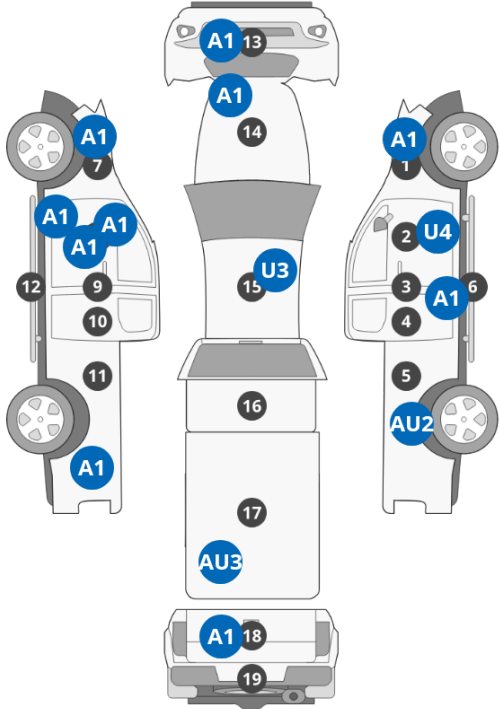
| Inspector Notes |
|---|
| with Ito plate/with spare tire/without spare key/without warranty booklet/with dent and hairlines scratches on the body/with jack no tools/without reverse camera |
