## General Information

| Make | Toyota | Model | Hilux Tamaraw |
| Registration No. | DCA8144 | Chassis No. | PAHAD9DA2S1627611 |

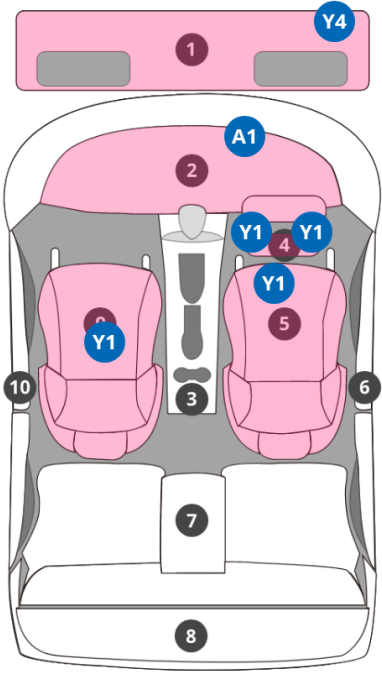
| Interior Evaluation : <b>C</b> | Exterior Evaluation : <b>D</b> |
|---|---|
| <p><b>Remarks</b></p> <p>Ceiling - Grime - Large / (L) Front Floor Mat - Grime - Minimal / (R) Front Floor Mat - Grime - Minimal / (R) Front Seat - Grime - Minimal / (L) Front Seat - Grime - Minimal / Dashboard - Worn, Scratch, Cut, Crack - Minimal</p> | <p><b>Remarks</b></p> <p>(R) Front Fender, Molding - Dent - Large / (R) Mirror - Scratch, Peeled - Minimal / (R) Front Door, Molding - Scratch &amp; Dent - Small / (R) Side Gate - Scratch &amp; Dent - Medium / Cargo Bed Floor - Scratch - Large / Rear Gate - Scratch - Small / (L) Side Gate - Scratch - Small / (L) Front Door, Molding - Scratch - Small / (L) Mirror - Scratch - Minimal / Roof - Dent - Small / (L) Front Fender, Molding - Scratch - Minimal / Front Bumper, Grille, Lamps - Crack, Gap - Large / Bonnet, Headlight - Scratch - Minimal</p> |
