## General Information

| Make | Toyota | Model | Vios |
| YOM | 2021 | Mileage | 65,949 |

## Body / Panel Condition

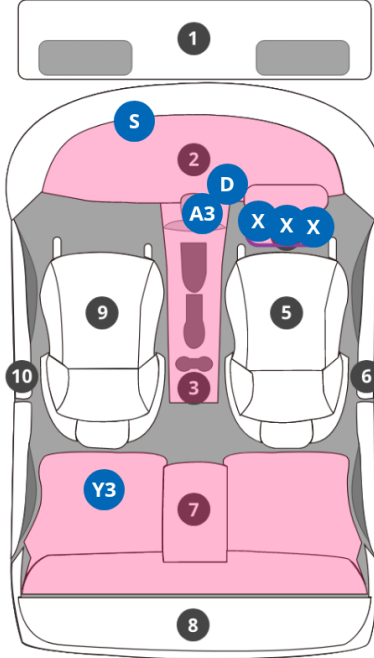
| Interior Evaluation : <span style="color: red; font-weight: bold; font-size: 1.2em;">B</span> | Exterior Evaluation : <span style="color: red; font-weight: bold; font-size: 1.2em;">D</span> |
| <p><b>Remarks</b></p> <p>Mat Other - Missing - Yes / (R) Front Floor Mat - Missing - Yes / (L) Front Floor Mat - Missing - Yes / Rear Seat - Grime - Medium / Console, Switchs, Vents - Worn, Scratch, Cut, Crack - Medium / Dashboard - Traces of Adhesive Tape - Yes / Overall Interior - Smell - Yes</p> | <p><b>Remarks</b></p> <p>(L) Rear Door, Molding - Scratch &amp; Dent - Medium / (L) Rear Fender, Molding - Scratch &amp; Dent - Small / (R) Rear Fender, Molding - Scratch &amp; Dent - Large / Trunk Hood, Rear Gate - Dent - Minimal / Rear Bumper, Lamps, Panels - Scratch &amp; Dent - Medium / (R) Rear Door, Molding - Scratch - Medium / (R) Front Door, Molding - Scratch &amp; Dent - Small / Bonnet, Headlight - Scratch - Small / (L) Mirror - Scratch - Small / Front Bumper, Grille, Lamps - Repair mark - Yes / Front Bumper, Grille, Lamps - Dent - Small</p> |
