## General Information

| Make | Toyota | Model | Vios |
| Registration No. | CCG6488 | Chassis No. | PA1B18F31R4274954 |

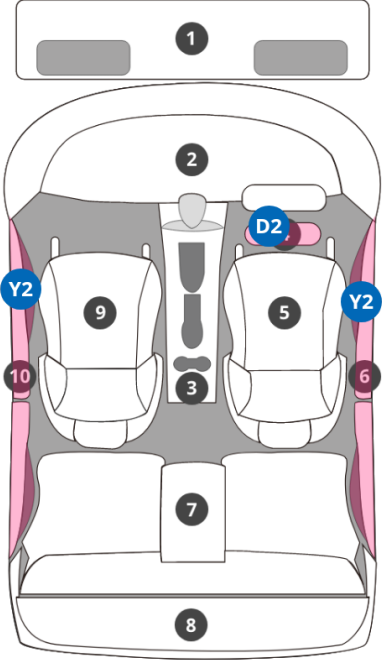
| Interior Evaluation : <span style="color: red; font-weight: bold;">A</span> | Exterior Evaluation : <span style="color: red; font-weight: bold;">B</span> |
| <b>Remarks</b><br>(L) Front Trim - Grime - Small / (R) Front Trim - Grime - Small / (L) Front Floor Mat - Worked - Small | <b>Remarks</b><br>Rear Bumper, Lamps, Panels - Scratch & Dent - Medium / (R) Rear Door, Molding - Dent - Small / Bonnet, Headlight - Scratch - Medium / Front Bumper, Grille, Lamps - Scratch & Dent - Medium / (L) Rear Door, Molding - Scratch - Small |

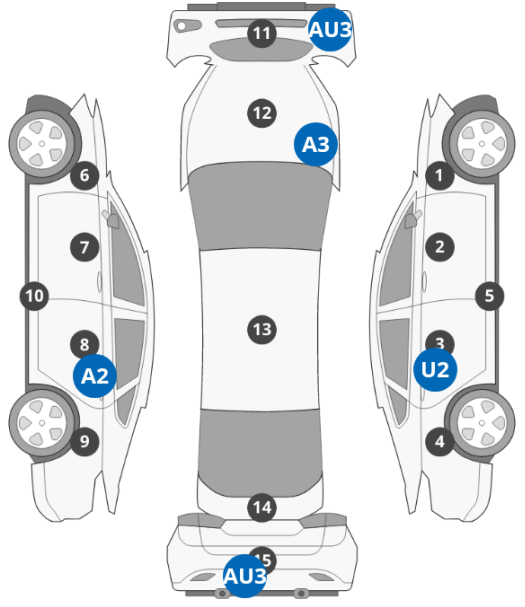
| Inspector Notes |
|---|
| no spare tire/ light scratches around the exterior/ with jack and spare tire/ with LTO plate and warranty booklet/ |
