## General Information

| Make | Toyota | Model | Vios |

## Body / Panel Condition

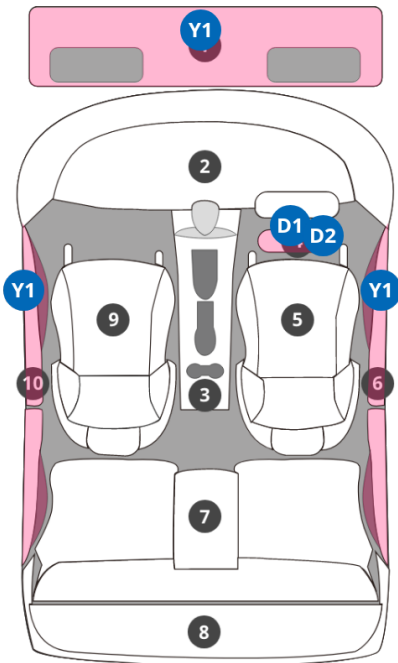
| Interior Evaluation : <b>A</b> | Exterior Evaluation : <b>B</b> |
| <p><b>Remarks</b><br/>Ceiling - Grime - Minimal / (R) Front Trim - Grime - Minimal / (L) Front Trim - Grime - Minimal / Carpet - Worked - Minimal / (L) Front Floor Mat - Worked - Small</p> | <p><b>Remarks</b><br/>Bonnet - Repair Traces - Yes / (L) Front Fender - Repair Traces - Yes / Roof - Repair Traces - Yes / (R) Front Fender, Molding - Scratch - Minimal / (R) Front Door, Molding - Scratch - Minimal / (R) Rear Door, Molding - Scratch &amp; Dent - Medium / (R) Step, In-panel, Side Spoiler - Scratch - Minimal / (R) Rear Fender, Molding - Scratch - Minimal / Rear Bumper, Lamps, Panels - Scratch - Minimal / Trunk Hood, Rear Gate - Scratch - Minimal / (L) Rear Fender, Molding - Scratch - Minimal / (L) Rear Door, Molding - Scratch - Minimal / (L) Front Door, Molding - Scratch - Minimal / (L) Front Fender, Molding - Scratch - Minimal / Bonnet, Headlight - Scratch - Minimal / Front Bumper, Grille, Lamps - Scratch - Minimal / (L) Step, In-panel, Side Spoiler - Scratch - Minimal</p> |

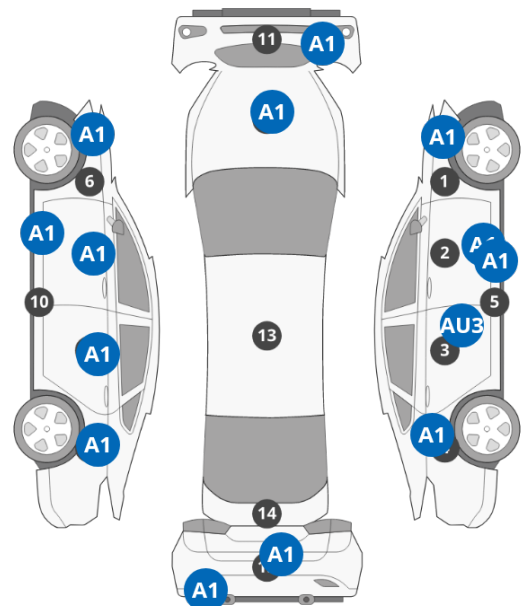
| Inspector Notes |
|---|
| With Lto plate, with spare tire and jack, 3keys, no warranty booklet and tools, scratches on headlights and taillights,visible hairlines scratches on vehicle |
