## General Information

| Make | Toyota | Model | Innova |
| Registration No. | NKO4790 | Chassis No. | PA2JA8EM6S0154484 |

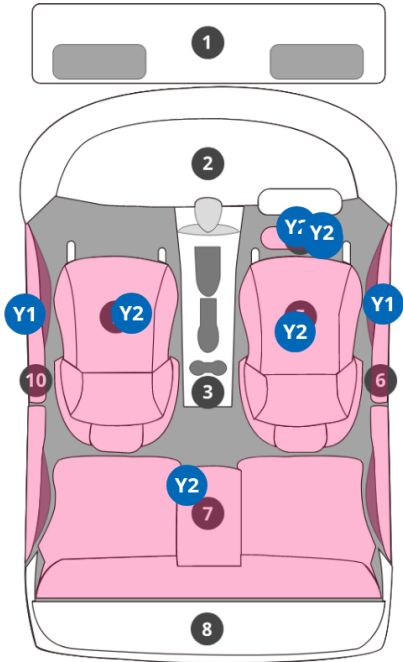
| Interior Evaluation : <b>B</b> | Exterior Evaluation : <b>C</b> |
|---|---|
| <p><b>Remarks</b><br/>(L) Front Floor Mat - Grime - Small / (R) Front Floor Mat - Grime - Small / (L) Front Seat - Grime - Small / (R) Front Seat - Grime - Small / Rear Seat - Grime - Small / (L) Front Trim - Grime - Minimal / (R) Front Trim - Grime - Minimal / Mat Other - Grime - Small</p> | <p><b>Remarks</b><br/>(R) Front Fender - Repair Traces - Yes / (L) Front Fender - Repair Traces - Yes / (R) Front Fender, Molding - Scratch &amp; Dent - Minimal / Front Bumper, Grille, Lamps - Scratch - Medium / Bonnet, Headlight - Scratch &amp; Dent - Small / (L) Front Fender, Molding - Scratch &amp; Dent - Minimal / (L) Front Door, Molding - Scratch - Small / (L) Rear Door, Molding - Scratch &amp; Dent - Minimal / (L) Step, In-panel, Side Spoiler - Scratch &amp; Dent - Minimal / (L) Rear Fender, Molding - Scratch - Small / Roof - Scratch &amp; Dent - Small / Trunk Hood, Rear Gate - Scratch - Small / Rear Bumper, Lamps, Panels - Scratch - Medium / (R) Rear Fender, Molding - Scratch - Small / (R) Rear Door, Molding - Scratch &amp; Dent - Minimal / (R) Step, In-panel, Side Spoiler - Scratch - Minimal / (R) Front Door, Molding - Scratch &amp; Dent - Minimal</p> |

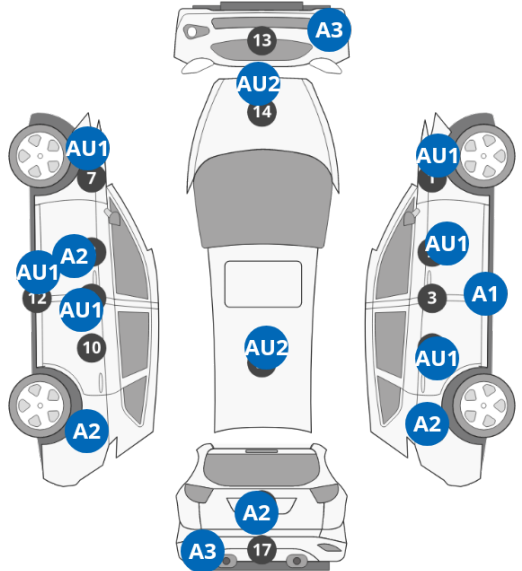
| Inspector Notes |
|---|
| with LTO plate, with spare tire and key, with jack and tools, with manual and warranty booklet, with reverse camera, scratches and dent on exterior, scratches in taillight and headlight. |
