## General Information

| Make | Toyota | Model | Ativ |

## Body / Panel Condition

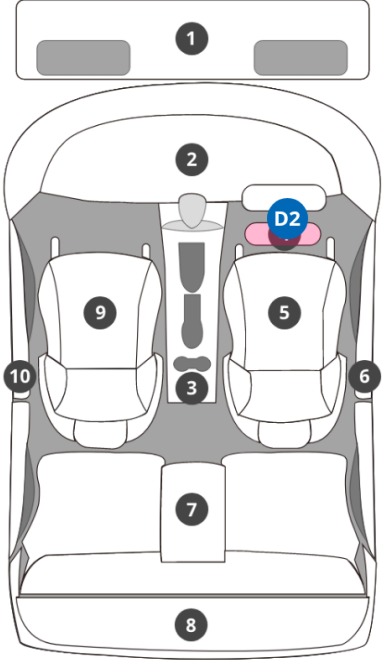
| Interior Evaluation : <b>A</b> | Exterior Evaluation : <b>C</b> |
| <b>Remarks</b><br>(L) Front Floor Mat - Worked - Small | <b>Remarks</b><br>(R) Front Fender, Molding - Scratch & Dent - Minimal / (R) Front Door, Molding - Scratch - Minimal / (R) Step, In-panel, Side Spoiler - Scratch - Minimal / (R) Rear Fender, Molding - Scratch - Minimal / Rear Bumper, Lamps, Panels - Scratch & Dent - Large / Trunk Hood, Rear Gate - Scratch - Minimal / (L) Rear Door, Molding - Scratch - Minimal / (L) Step, In-panel, Side Spoiler - Scratch - Minimal / (L) Front Door, Molding - Scratch & Dent - Small / (R) Rear Door, Molding - Scratch & Dent - Minimal / Front Bumper, Grille, Lamps - Scratch & Dent - Small / Bonnet, Headlight - Scratch - Minimal / (L) Front Fender, Molding - Scratch - Minimal |

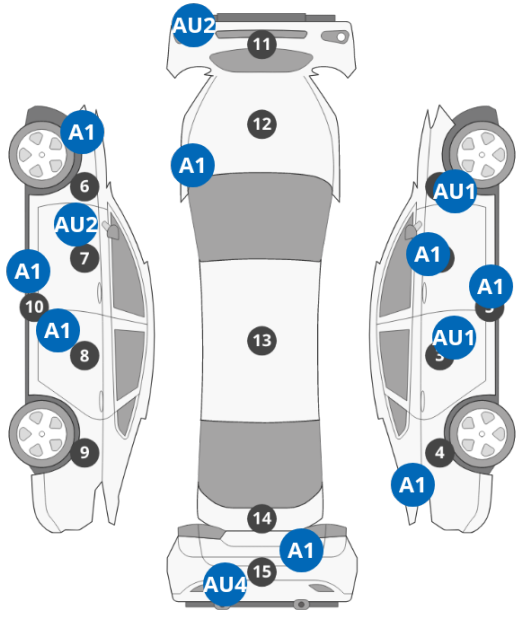
| Inspector Notes |
|---|
| With Lto plate, with spare tire and jack, with warranty booklet, 2keys, no tools, scratches on headlights,oil deterioration light on |
