## General Information

| Make | Toyota | Model | Veloz |

## Body / Panel Condition

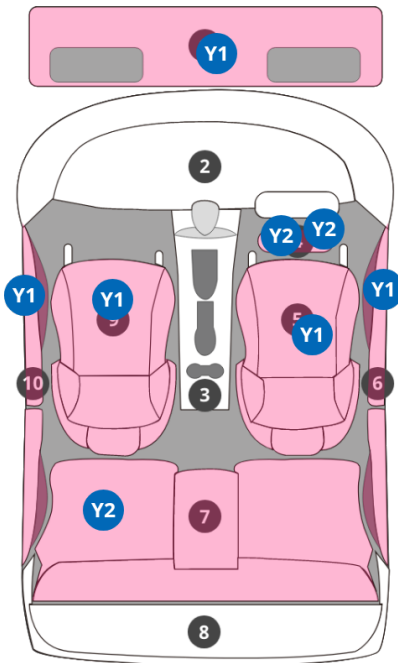
| Interior Evaluation : <b>B</b> | Exterior Evaluation : <b>C</b> |
|---|---|
| <p><b>Remarks</b><br/>(L) Front Floor Mat - Grime - Small / (R) Front Floor Mat - Grime - Small / Rear Seat - Grime - Small / (L) Front Seat - Grime - Minimal / (R) Front Seat - Grime - Minimal / (L) Front Trim - Grime - Minimal / (R) Front Trim - Grime - Minimal / Ceiling - Grime - Minimal</p> | <p><b>Remarks</b><br/>(R) Front Fender - Repair Traces - Yes / Bonnet - Repair Traces - Yes / (L) Front Fender - Repair Traces - Yes / (R) Rear Fender, Molding - Scratch &amp; Dent - Small / Trunk Hood, Rear Gate - Scratch &amp; Dent - Small / (L) Rear Fender, Molding - Scratch - Medium / (R) Rear Door, Molding - Scratch &amp; Dent - Minimal / (R) Front Door, Molding - Scratch &amp; Dent - Minimal / (R) Front Fender, Molding - Scratch - Small / Front Bumper, Grille, Lamps - Scratch - Small / (L) Front Fender, Molding - Scratch &amp; Dent - Small / (L) Front Door, Molding - Scratch &amp; Dent - Small / (L) Rear Door, Molding - Scratch - Minimal / Roof - Dent - Small / Bonnet, Headlight - Scratch &amp; Dent - Minimal / (R) Step, In-panel, Side Spoiler - Scratch - Minimal / Rear Bumper, Lamps, Panels - Scratch - Small</p> |

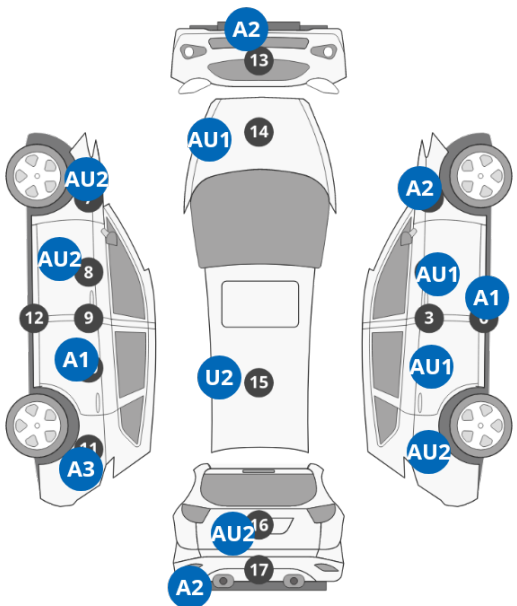
| Inspector Notes |
|---|
| with LTO plate, with warranty and manual booklet, with reverse camera, with spare tire, with jack and inc tools, no spare key, scratches and dent on exterior, scratches in taillight and headlight. |
