## General Information

| Make | Toyota | Model | Vios |
| Registration No. | NKG4910 | Chassis No. | PA1B18F35R4275315 |

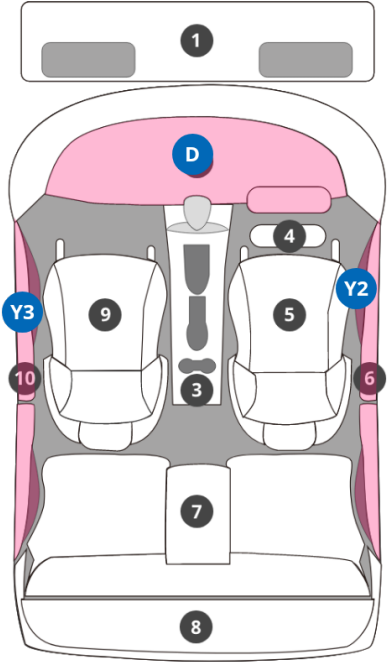
| Interior Evaluation : <b>B</b> | Exterior Evaluation : <b>E</b> |
|---|---|
| <p><b>Remarks</b><br/>Dashboard - Traces of Adhesive Tape - Yes / (L) Front Trim - Grime - Medium / (R) Front Trim - Grime - Small</p> | <p><b>Remarks</b><br/>(L) Front Fender - Repair Traces - Yes / Bonnet, Headlight - Dent - Medium / Front Bumper, Grille, Lamps - Dent - Large / (R) Front Fender, Molding - Crack, Gap - Medium / (R) Front Door, Molding - Scratch - Small / (R) Rear Door, Molding - Scratch &amp; Dent - Large / (R) Rear Fender, Molding - Scratch &amp; Dent - Large / Rear Bumper, Lamps, Panels - Scratch &amp; Dent - Large / (L) Rear Fender, Molding - Scratch &amp; Dent - Large / (L) Rear Door, Molding - Scratch &amp; Dent - Medium / (L) Front Door, Molding - Scratch - Small / (L) Front Fender, Molding - Dent - Small / (L) Front Fender, Molding - Repair mark - Yes</p> |
