## General Information

| Make | Toyota | Model | Vios |

## Body / Panel Condition

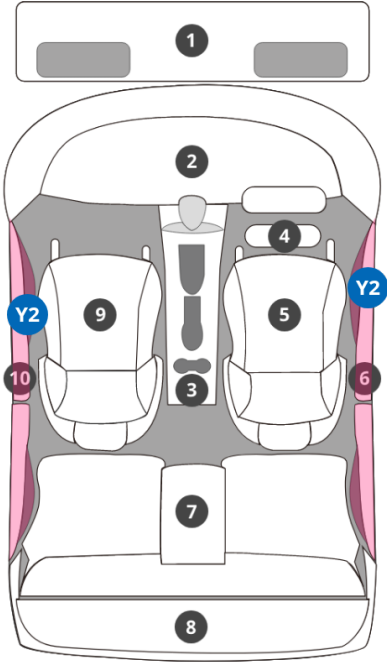
| Interior Evaluation : <b>A</b> | Exterior Evaluation : <b>D</b> |
| <b>Remarks</b><br>(L) Front Trim - Grime - Small / (R) Front Trim - Grime - Small | <b>Remarks</b><br>Rear Bumper, Lamps, Panels - Scratch - Large / (L) Rear Fender, Molding - Scratch - Small / (L) Rear Door, Molding - Scratch - Large / (L) Front Door, Molding - Scratch - Large / (L) Step, In-panel, Side Spoiler - Scratch & Dent - Medium / Front Bumper, Grille, Lamps - Scratch - Medium / (R) Rear Fender, Molding - Scratch - Minimal / (R) Rear Door, Molding - Scratch - Minimal / (R) Front Door, Molding - Scratch - Minimal / (R) Front Fender, Molding - Scratch - Minimal / Trunk Hood, Rear Gate - Scratch - Minimal / Bonnet, Headlight - Scratch - Minimal |

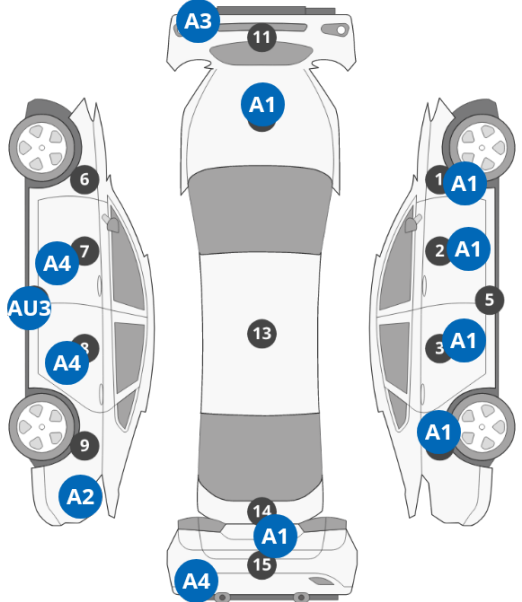
| Inspector Notes |
|---|
| no tools and spare tire/ light scratches around the exterior/ with jack and LTO plate/ with warranty booklet |
