## General Information

| Make | Toyota | Model | Vios |
| Registration No. | NKB7229 | Chassis No. | PA1B18F32R4249769 |

## Body / Panel Condition

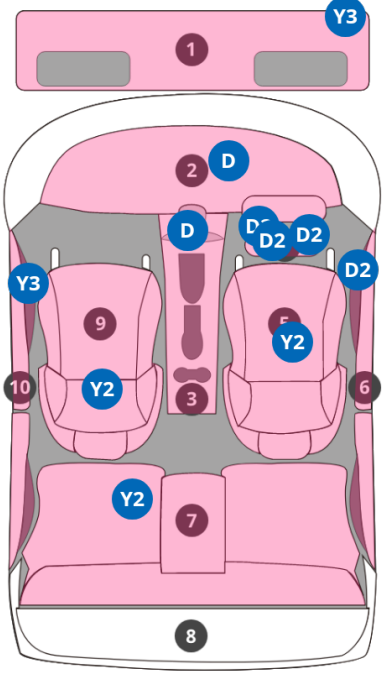
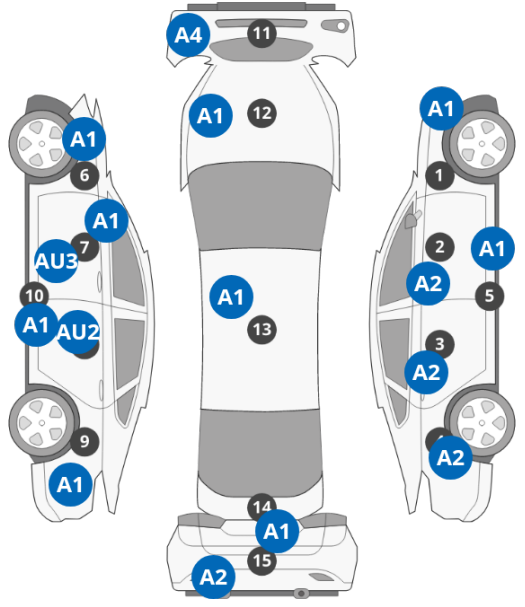
| Interior Evaluation : <b>C</b> | Exterior Evaluation : <b>C</b> |
|---|---|
| <b>Remarks</b><br>(R) Front Floor Mat - Worked - Small / (L) Front Floor Mat - Worked - Small / Dashboard - Traces of Adhesive Tape - Yes / (L) Front Seat - Grime - Small / (R) Front Seat - Grime - Small / Rear Seat - Grime - Small / (L) Front Trim - Grime - Medium / (R) Front Trim - Worked - Small / Console, Switchs, Vents - Traces of Adhesive Tape - Yes / Ceiling - Grime - Medium / Mat Other - Worked - Small | <b>Remarks</b><br>(R) Front Fender, Molding - Scratch - Minimal / (R) Front Door, Molding - Scratch - Small / (R) Rear Door, Molding - Scratch - Small / (R) Step, In-panel, Side Spoiler - Scratch - Minimal / (R) Rear Fender, Molding - Scratch - Small / Rear Bumper, Lamps, Panels - Scratch - Small / Trunk Hood, Rear Gate - Scratch - Minimal / (L) Rear Fender, Molding - Scratch - Minimal / (L) Rear Door, Molding - Scratch & Dent - Small / (L) Front Door, Molding - Scratch & Dent - Medium / (L) Mirror - Scratch - Minimal / (L) Front Fender, Molding - Scratch - Minimal / (L) Step, In-panel, Side Spoiler - Scratch - Minimal / Front Bumper, Grille, Lamps - Scratch - Large / Bonnet, Headlight - Scratch - Minimal / Roof - Scratch - Minimal |
