## General Information

| Make | Toyota | Model | Vios |
| Registration No. | NJK3207 | Chassis No. | PA1B18F31S4299441 |

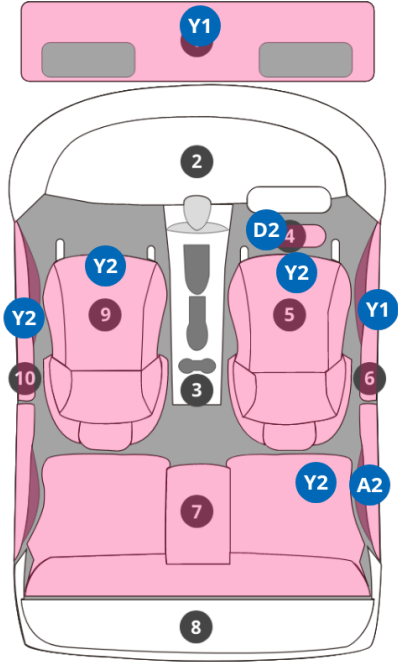
| Interior Evaluation : <b>B</b> | Exterior Evaluation : <b>E</b> |
|---|---|
| <p><b>Remarks</b></p> <p>(R) Front Seat - Grime - Small / (L) Front Seat - Grime - Small / (L) Front Floor Mat - Worked - Small / (L) Front Trim - Grime - Small / (R) Front Trim - Grime - Minimal / (R) Rear Trim - Cut, Crack - Small / Rear Seat - Grime - Small / Ceiling - Grime - Minimal</p> | <p><b>Remarks</b></p> <p>(R) Front Fender, Molding - Scratch - Small / (R) Mirror - Scratch - Minimal / (R) Step, In-panel, Side Spoiler - Scratch - Medium / (R) Front Door, Molding - Scratch - Minimal / (R) Rear Door, Molding - Scratch - Medium / (R) Rear Fender, Molding - Scratch - Medium / Rear Bumper, Lamps, Panels - Scratch - Medium / Trunk Hood, Rear Gate - Scratch - Medium / (L) Rear Fender, Molding - Scratch - Minimal / (L) Rear Door, Molding - Scratch - Small / (L) Front Door, Molding - Scratch - Small / (L) Step, In-panel, Side Spoiler - Scratch - Medium / (L) Mirror - Scratch - Small / (L) Front Fender, Molding - Scratch - Medium / Front Bumper, Grille, Lamps - Scratch &amp; Dent - Medium / Bonnet, Headlight - Scratch - Small / Roof - Scratch - Minimal</p> |

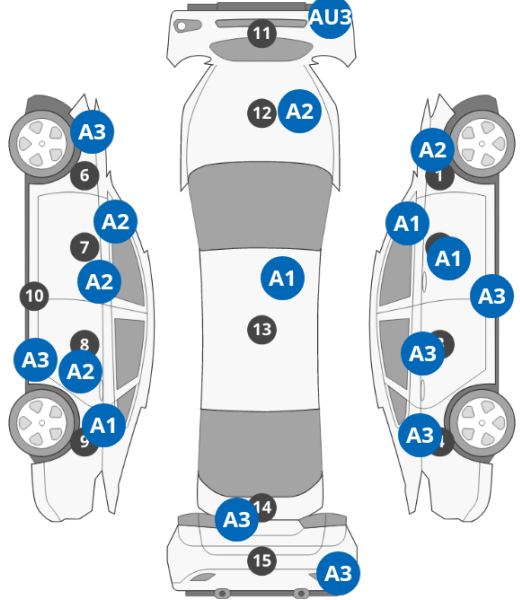
| Inspector Notes |
|---|
| with warranty booklet and jack, incomplete tools, with spare tire, with LTO plate, scratches on headlight and tail light, cracked headlight |
