## General Information

| Make | Toyota | Model | Vios |

## Body / Panel Condition

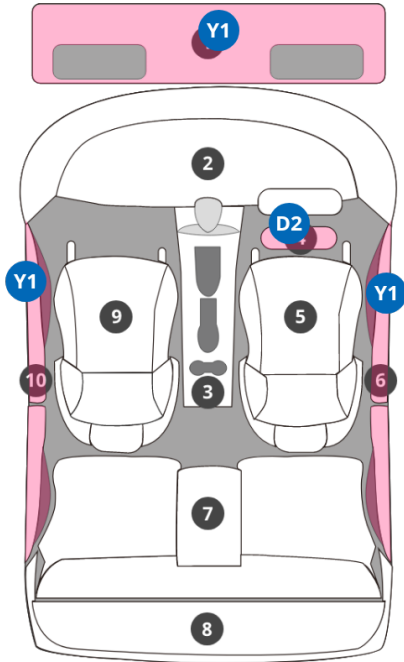
| Interior Evaluation : <b>A</b> | Exterior Evaluation : <b>C</b> |
|---|---|
| <p><b>Remarks</b><br/>Ceiling - Grime - Minimal / (L) Front Floor Mat - Worked - Small / (L) Front Trim - Grime - Minimal / (R) Front Trim - Grime - Minimal</p> | <p><b>Remarks</b><br/>(R) Step, In-panel, Side Spoiler - Scratch &amp; Dent - Minimal / (R) Rear Door, Molding - Scratch &amp; Dent - Large / (R) Rear Fender, Molding - Scratch &amp; Dent - Medium / Rear Bumper, Lamps, Panels - Scratch - Minimal / Trunk Hood, Rear Gate - Scratch - Minimal / (L) Rear Fender, Molding - Scratch - Minimal / (R) Front Fender, Molding - Scratch &amp; Dent - Minimal / (R) Front Door, Molding - Scratch - Minimal / (L) Rear Door, Molding - Scratch - Minimal / (L) Front Door, Molding - Scratch - Minimal / (L) Front Fender, Molding - Scratch - Minimal / Front Bumper, Grille, Lamps - Scratch - Minimal / Bonnet, Headlight - Scratch - Minimal</p> |

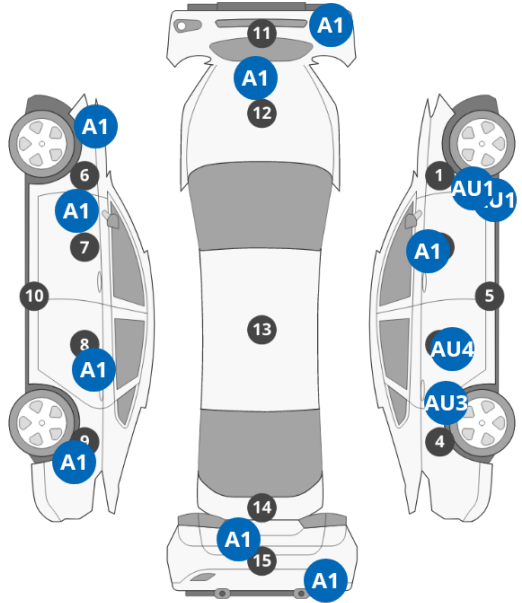
With Lto plate, with spare tire and jack, with warranty booklet, 2keys, no tools, scratches on headlights and taillights
