## General Information

| Make | Toyota | Model | Avanza |

## Body / Panel Condition

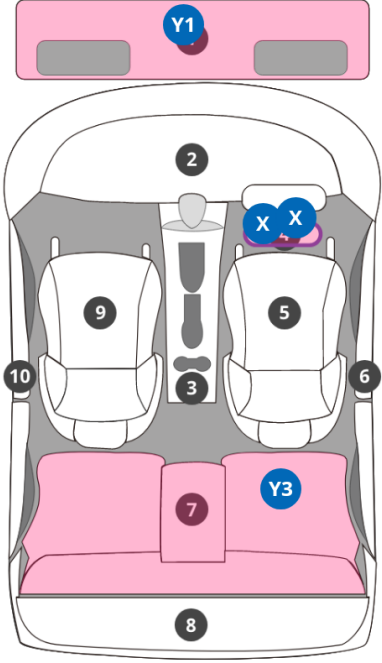
| Interior Evaluation : <b>B</b> | Exterior Evaluation : <b>C</b> |
|---|---|
| <p><b>Remarks</b></p> <p>Rear Seat - Grime - Medium / (R) Front Floor Mat - Missing - Yes / (L) Front Floor Mat - Missing - Yes / Ceiling - Grime - Minimal</p> | <p><b>Remarks</b></p> <p>(R) Front Fender, Molding - Scratch - Minimal / (R) Mirror - Scratch - Minimal / (R) Front Door, Molding - Scratch - Minimal / (R) Step, In-panel, Side Spoiler - Scratch - Minimal / (R) Rear Door, Molding - Scratch - Minimal / (R) Rear Fender, Molding - Scratch &amp; Dent - Small / Rear Bumper, Lamps, Panels - Scratch - Medium / Trunk Hood, Rear Gate - Scratch - Minimal / (L) Rear Fender, Molding - Scratch - Minimal / (L) Rear Door, Molding - Scratch - Minimal / (L) Front Door, Molding - Scratch - Small / (L) Step, In-panel, Side Spoiler - Scratch - Minimal / (L) Front Fender, Molding - Scratch - Minimal / Front Bumper, Grille, Lamps - Scratch - Medium / Bonnet, Headlight - Scratch - Small / (L) Mirror - Scratch - Minimal</p> |

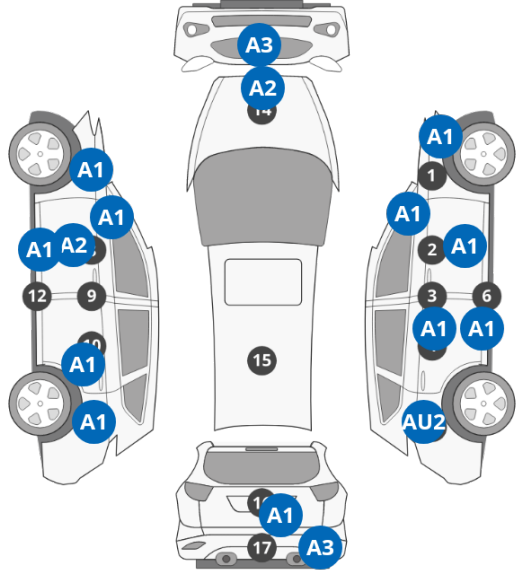
| Inspector Notes |
|---|
| With Lto plate, with spare tire and warranty booklet, 2keys, no jack and tools, scratches on headlights, |
